**NW Corridor Transit Planning
Union Station Existing Conditions
Technical Memorandum
(Physical and Operational
Assessments)**

**Capitol Region Council of
Governments**

October 24, 2007

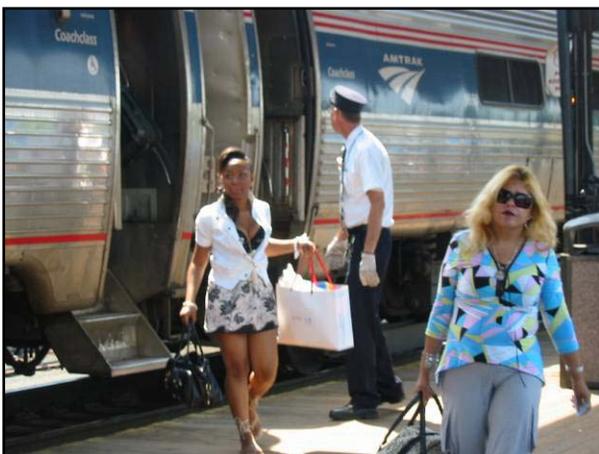
Photo 20 – Passengers Disembarking from Amtrak Train (Note not along area of tactile warning strip)

The only area of accessibility concern is on the loading platform for Amtrak. As discussed previously, while a tactile warning strip is present for a portion of the platform, loading and unloading operations were observed to occur in an area without the tactile strip.

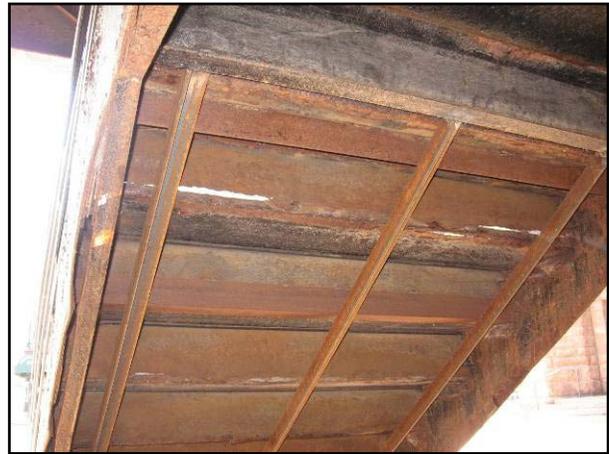
- The steel-framed stairs on the north and south ends of the central platform that are used for emergency egress from the second and third floors of Union Station are significantly rusted (see Photos 30 and 31). Supplementary angle framing has been added to the underside of the steel riser/tread pans apparently in an effort to strengthen the steps. The load carrying capacity of the steps has obviously been compromised. We consider the condition of the stairs a safety concern and recommend that the stairs be closed and repairs initiated immediately. According to GHTD, the City of Hartford's Fire Marshall and Building Inspectors offices have also noted these deficiencies and Amtrak is aware that they may be receiving written notification or be cited for safety violations within their leasehold area.

Photo 31 – Underside of Steel Stairs Serving East Platform

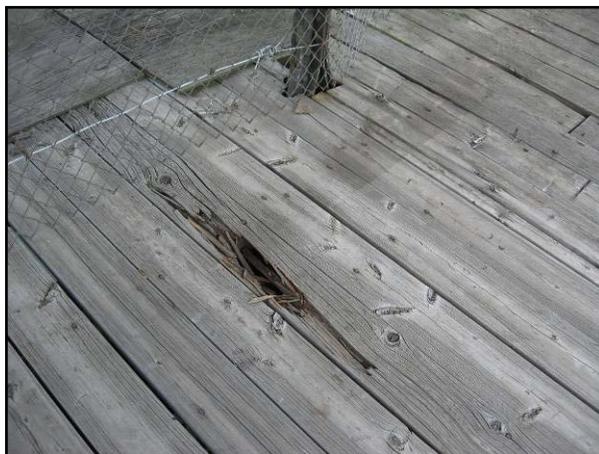
- At several locations, the timber floor planks at on the central platform are deteriorated and should be replaced (see Photo 34). At one location, a piece of wood decking has been applied above a deteriorated section of deck (see Photo 35). This repair has created a trip hazard immediately adjacent to the active Amtrak line and should be corrected.

Photo 34 – Deteriorated Floor Plank, North End of Central Platform

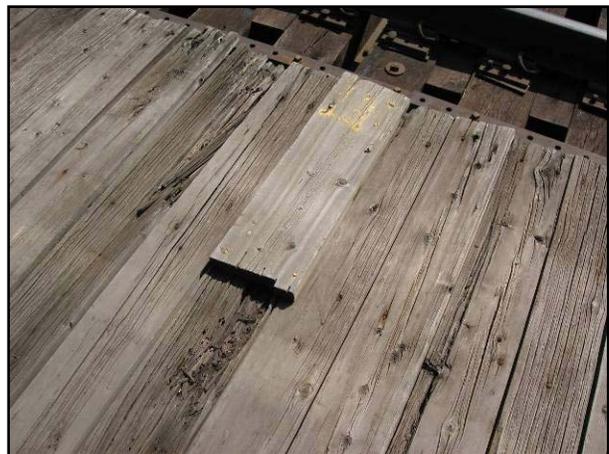
Photo 35 – Repair Plank Applied to Top of Central Platform, Adjacent to Active Track

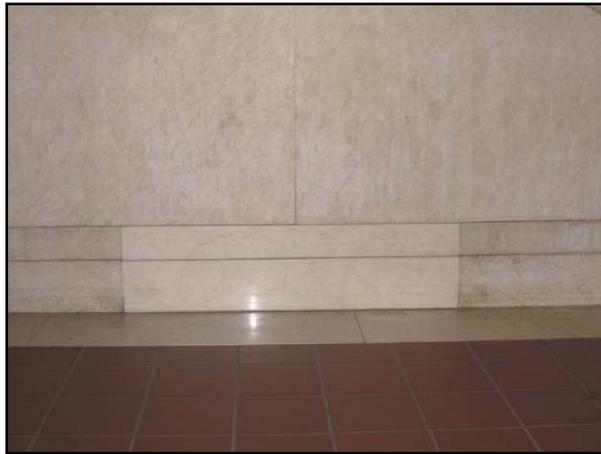
*Photo 36 – Replacement Marble in Great Hall
(Replacement made with original piece of marble
found on site. Notice difference in color)*

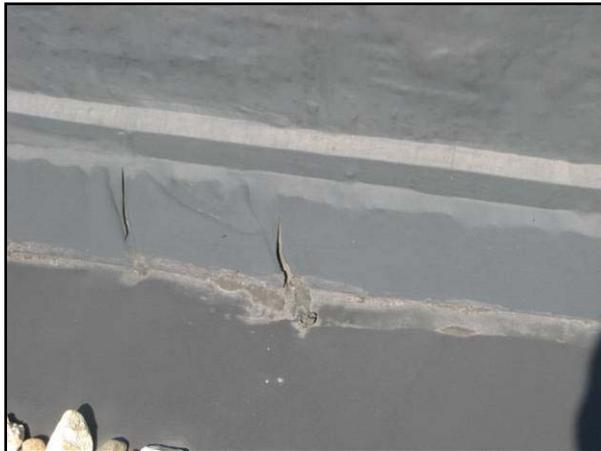
The roof over the Great Hall area is a ballasted EPDM system that goes up and over the parapet wall. It is a sloped system with roof drains collecting along the east and west sides of the building. Minor ponding was observed to have occurred at one point at the southeast corner of the roof based upon the mossy nature of the ballast and “path” that the water made as it flowed to the roof drain.⁷ Other areas of the EPDM adjacent to the parapet have begun to show some fatigue cracking. Based on an estimated installation of approximately 1984, the roof would be near the end of a typical lifespan depending on the grade of the material installed. Overall, it does appear to be in generally good condition and our recommendation would be to have a qualified contractor come in and complete a detailed inspection, replacing any areas of cracking or fatigue, including the flashing at the parapet.

Photo 38 – Example of Minor Cracking of EPDM Roof System at Parapet Wall

- Exterior components were overall good. The EPDM roofing over the Great Hall should be inspected for some minor observed cracks and patch repaired as required. Future major improvements may consider the reglazing of the windows in the Great Hall with low-e glass and restoration to operating status to reduce heating and cooling costs. The windows could also be restored to allow them to be opened, reducing the need for cooling during spring and fall seasons.

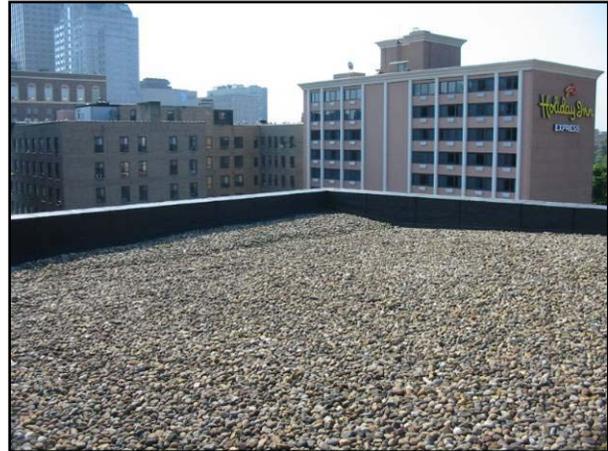
⁷ Although not confirmed by testing, it appears that this roof drain may be causing some damage to the interior plaster finish of the Great Hall on the southeast corner. Selective demolition of the damaged wall and ceiling area may be required to accurately determine the location of the water infiltration.

Photo 39 – Water Path from Southeast Corner of Great Hall to Roof Drain at East Edge (extreme right of photo)

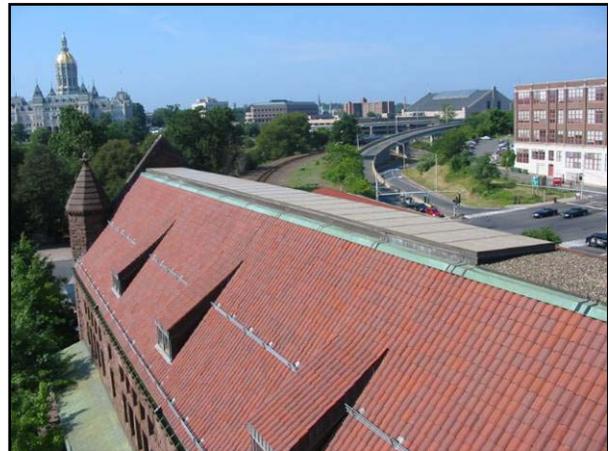
The roof over the wings of Union Station is steeply pitched with roof tiles with a center skylight on a very slight incline. Inspection was made from a distance on the Great Hall roof. The roof tiles appeared to be in fair condition. Concerns have been noted from both the GHTD and the 3rd floor wing tenants about the leaking of the skylights in those areas. It is very common for skylights to have leaking problems and closer inspection would be required to

Photo 41 – View of South Wing Roof and Skylight

determine the exact nature of where the flashing was failing. It may be worthwhile in the future to consider, if allowable by historic preservation regulations, to replace the single slope skylight with a pitched skylight that matches the roof tile clad pitch. This would increase the ability to shed water, but may have a visual impact to the existing structure that would not be acceptable to historic preservationists.

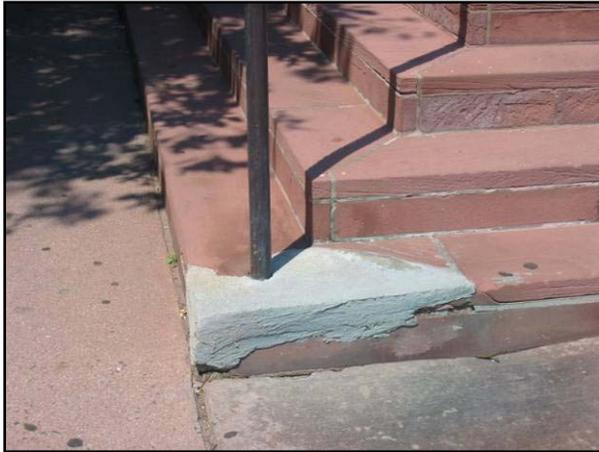
Photo 42 – Repair to Original Union Station Stairs

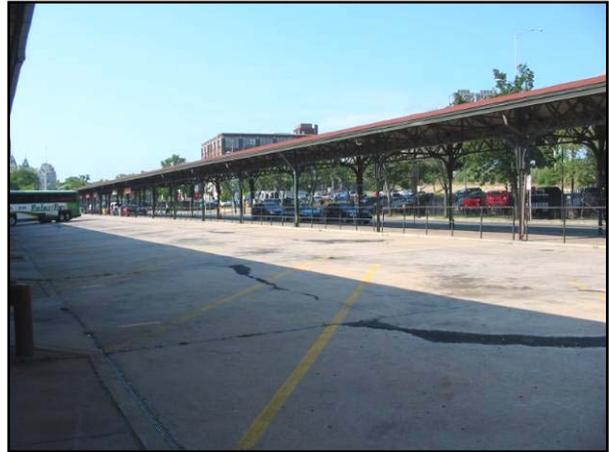
The major site concerns are at the Spruce Street side where the intercity bus stalls are located. First, the existing concrete pavement is showing significant failures which would be expected from its usage and lifespan. As some point within the next several years, this area will need to have a major pavement improvement and be replaced with new concrete. At that time, the drainage problems in the area should be addressed. The site was designed, according to record plans, and installed, according to visual observation, for the entire area from Spruce Street to sheet flow into a small trench drain located at the head of the bus stalls adjacent to the building. This area tends to flood in any major storm event. Without completing any hydraulic analysis, it appears that the trench drain is insufficient to handle the drainage. It would be advisable to complete a hydraulic analysis of the water and redesign the drainage system with the pavement replacement to better accommodate significant storm events.

Photo 43 – View of Bus Stall Pavement Showing Fatigue

- The exterior pavement at the bus loading area is showing significant fatigue and should be replaced. At that time, it is recommended to conduct a hydraulic analysis to redesign the drainage system to minimize flooding that currently occurs.

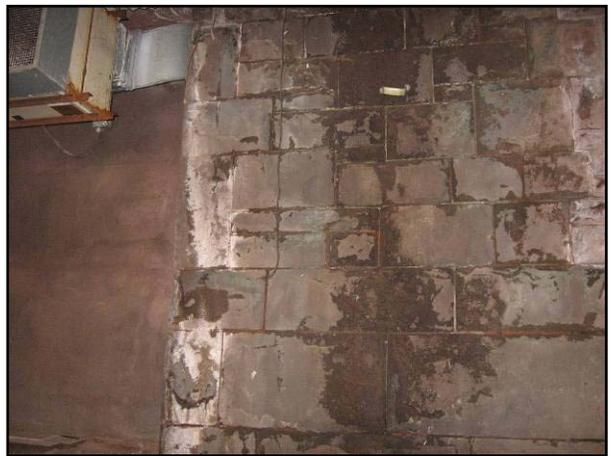
- Some deterioration of mortar joints was observed at ground level on the west side of the building, directly under the train platform. Those should be reviewed further and repaired as appropriate.

Photo 48 – Staining on Brownstone Bearing Wall; Mortar Joint Deterioration, West Face of Union Station

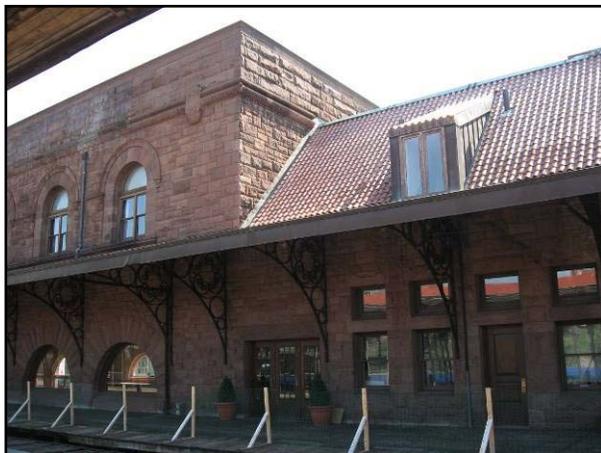
Photo 49 – West Face of Union Station (Note staining of Brownstone bearing wall below roof line, above windows)

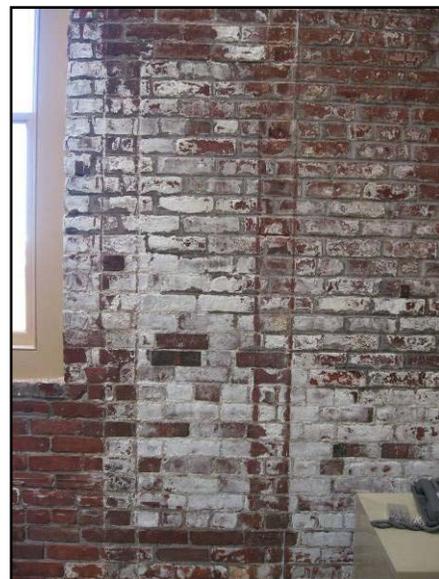
Photo 50 – North Wall of 3rd Floor Space (Note efflorescence on wall from moisture infiltration)

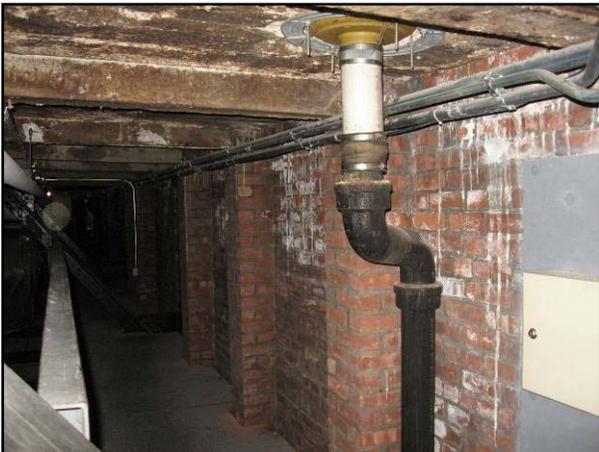
Photo 53 – Roof Drain at Great Hall. (Note evidence of leaking around drain at some time in past)

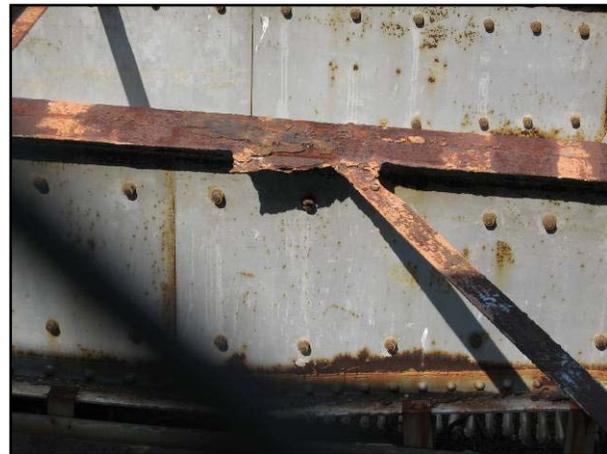
Photo 60 – Severe Rusting of Top Flange Beam Bracing. (Note missing symmetrical brace)

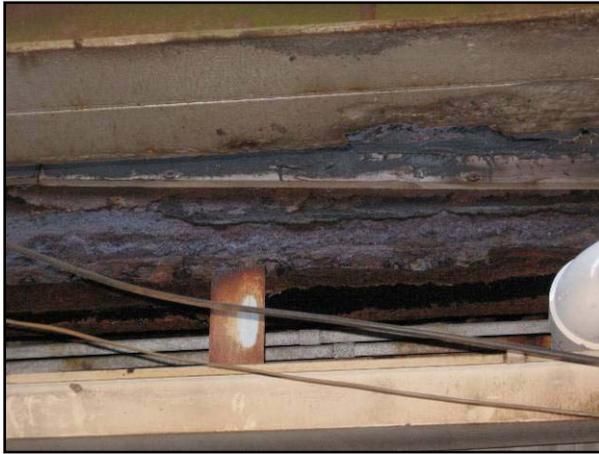
- The trestle structure supporting the Amtrak platforms and rail lines is in variable condition. Some of the exposed portions exhibit significant rusting to the point where there is the potential for the load carrying capacity to be compromised. Some bracing angles are rusted through or missing. Further inspection and analysis using destructing and non-destructive testing should be undertaken to determine the repairs. This would be an area of Amtrak responsibility, not GHTD. According to GHTD, the City of Hartford's Fire Marshall and Building Inspectors offices have also noted these deficiencies and have notified Amtrak.

Photo 61 – Rusted Bottom Flange of Trestle Beam, East Platform, North of Ground Transportation Center

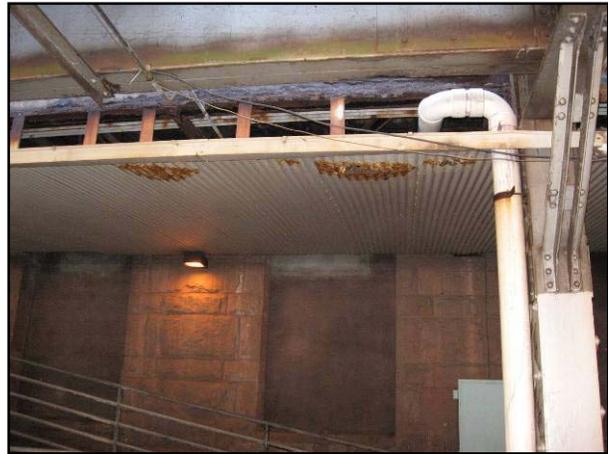
Photo 62 – Corrugated Steel Roof with Rusting Hanger Supports

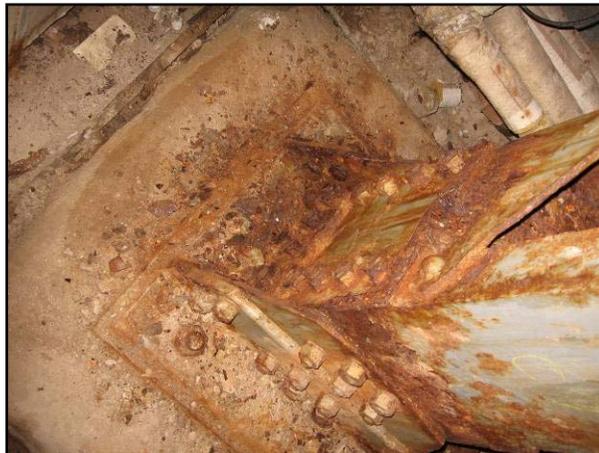
- The Ground Transportation Center has significant rusting on the bases of the laced columns supporting the Amtrak trestle and platform above. This appears to be from the pitch pans and roof drains that collect the water from the platform above. Repair should be made to the pitch pans to stop the leaking and associated damage.

- Significant rusting was observed on the columns and column bases at the pitch pan drain locations in the Ground Transportation Center (see Photos 63 & 64). It appears that there is chronic leaking in and around the pitch pan locations on the roof of the Transportation Center and water continues to drain down the columns. Flashing that has been installed around the columns at the roof appears to be ineffective in directing water away from the column (see Photo 65).
- Observations relating to the safety issues of the platform and egress stairs as documented in the architectural safety and security section.

Photo 63 – Significant Rusting at Laced Column Base of Trestle, Ground Transportation Center

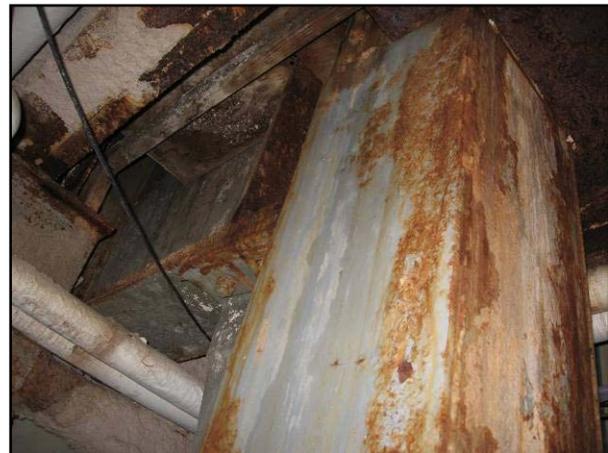
Photo 64 – Typical Rusting around Pitch Pan, near Laced Column, Roof of Ground Transportation Center

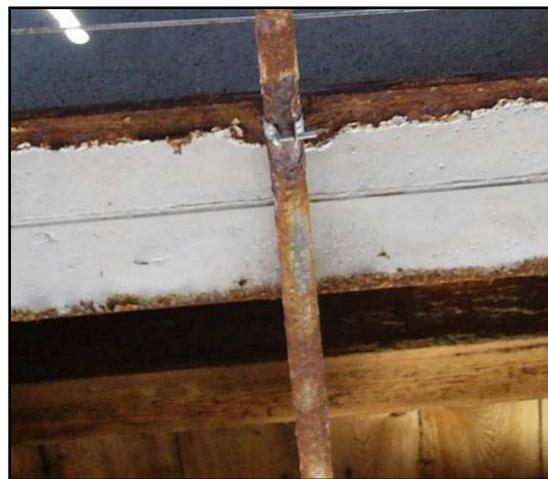
Photo 67 – Corroded Exterior Conduit

- All major service and distribution equipment appear to be in sound, working condition. Some outdoor conduits are exposed and should be replaced. All temporary wires should be replaced. It is recommended to place a ventilation system within the main electrical room to diffuse the heat generated from the step-down transformer to prolong the life of the electrical equipment.
- The exterior and Great Hall lights are continuously on. It is recommended to install a sensor to have these fixtures only on when light levels require.
- In the future, it may be warranted to consider installation of occupancy sensors, scheduled shut-offs, and multi-level switching in areas to reduce energy costs during any renovation project.

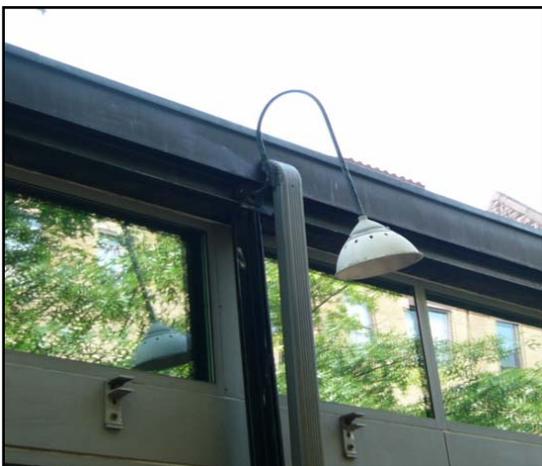
Photo 68 – Exterior Light (Damaged)

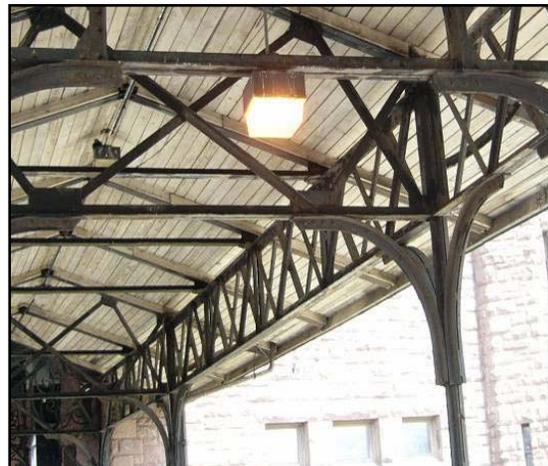
Photo 69 – Exterior Light (On during the day)

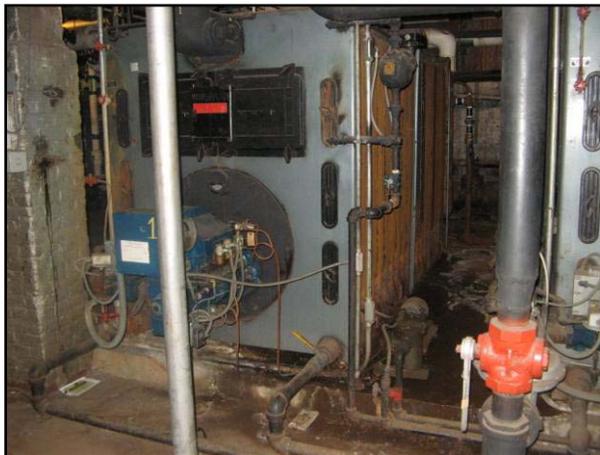
Photo 70 – Boiler #1 Down for Maintenance

⁸ It is within the current GHTD grant budget to replace the boilers.

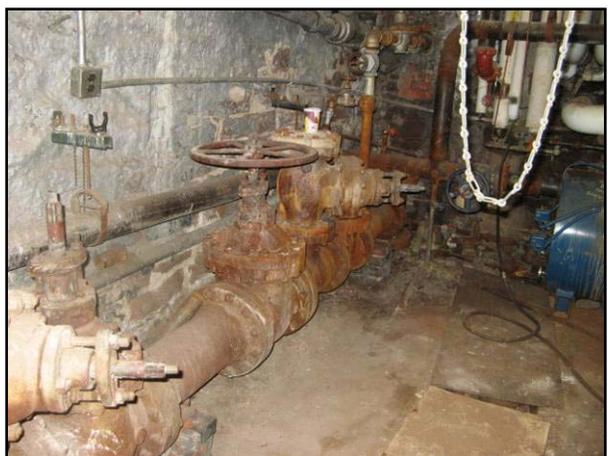
Photo 77 – Sample of Corroded Piping in Basement Mechanical Room

- Piping system (steam, hot water, chilled water system) including pipe and duct insulation needs replacement.
- While the water chillers have been operating satisfactorily with normal maintenance and repair, their useful service life has been seen. The units could possible operate for four to eight years. A replacement schedule should be created for this system.

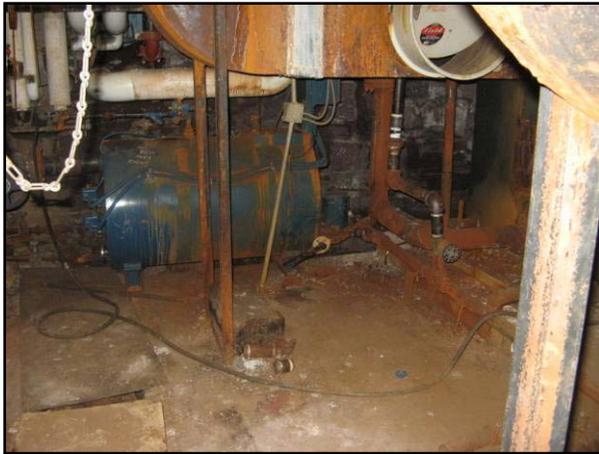
Photo 78 – Sample of Corroded Piping in Basement Mechanical Room

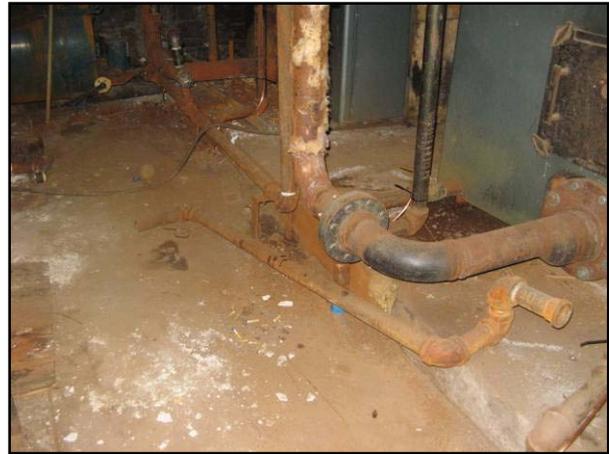
Photo 79 – Sample of Corroded Piping in Basement Mechanical Room (Note replacement piping)

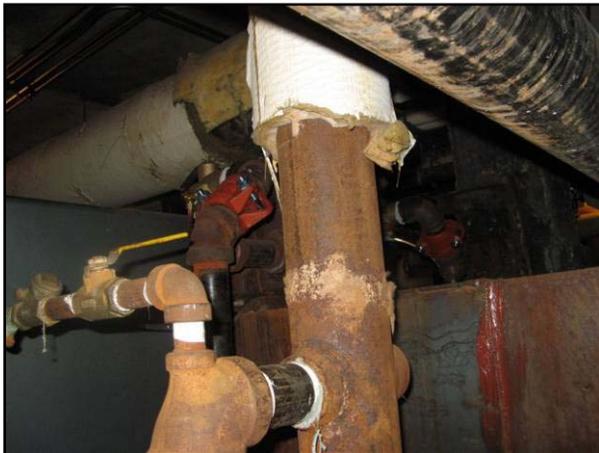
Photo 80 – Sample of Deteriorated Insulation in Basement Mechanical Room

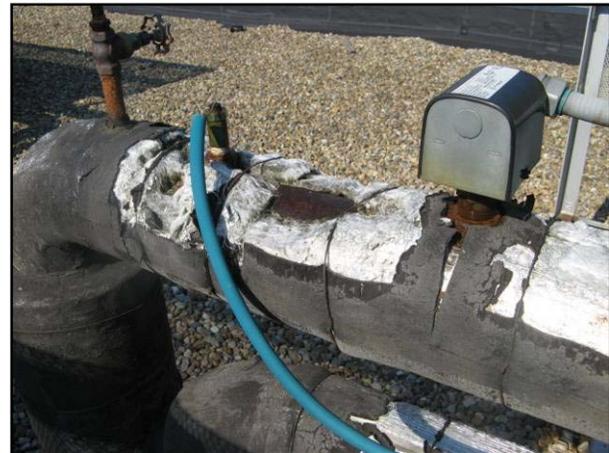
Photo 81 – Sample of Deteriorated Insulation at Air Cooled Water Chiller on Roof

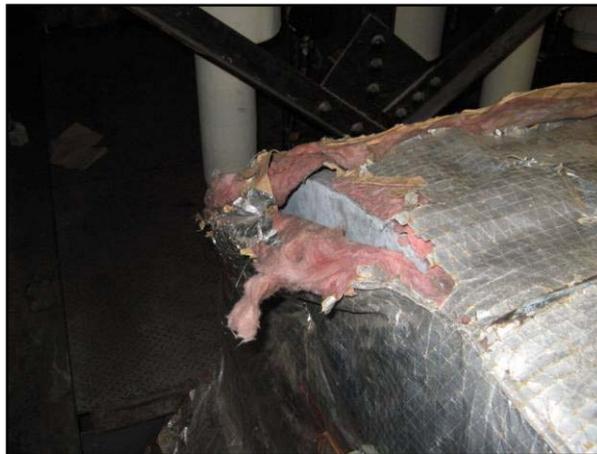
Photo 82 – Sample of Deteriorated Insulation in Attic above Great Hall
