BACKGROUND ON CONCRETE

Re: Consumer Protection Investigation of Crumbling Concrete Home Foundations

INVESTIGATING THE DETERIORATION OF BASEMENT WALLS MADE OF CONCRETE IN CT

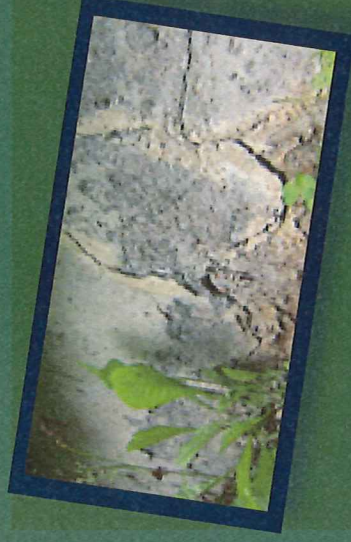
If the concrete in your basement walls has large cracks like ones pictured, your home's foundation may be damaged and **should be inspected.** An inspection can identify solutions to prevent long-term damage.

- Talk with a professional engineer about testing the concrete in your home for damage, and their recommended next steps for repair.
- You can verify that your professional engineer is licensed, and your home improvement contractor is registered at www.elicense.ct.gov.
- Contact the Connecticut Insurance Department to work through any insurance related questions or complaints.
- If you have questions or need support, please contact the Department of Consumer Protection at dcp.concrete@ct.gov.

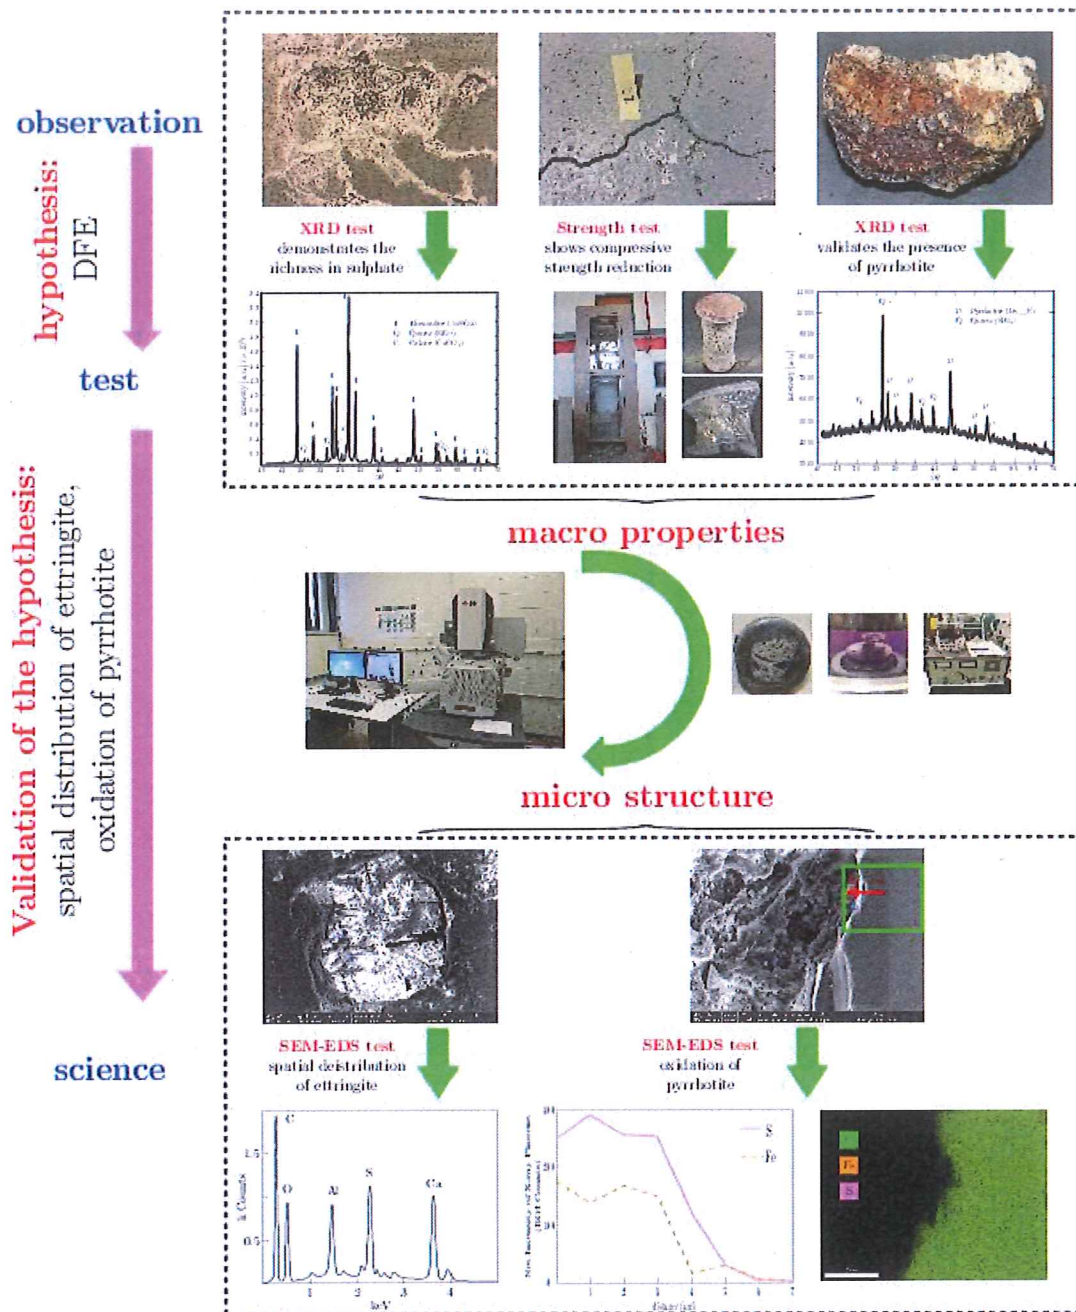
Fig. 1.1 Research Approach

Fig. 1.1 schematically summarizes the research approach, in which visible macroscopic properties are linked to scientific microstructural parameters.

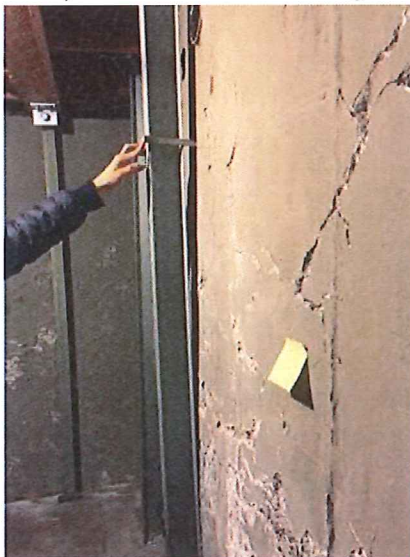
e) significant deformation of the concrete foundation wall

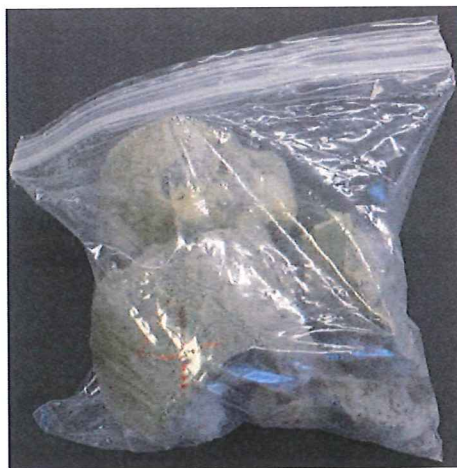
Fig. 4.4 Completely disintegrated core sample of concrete foundation wall– house 1

The compressive strength of individual specimens is summarized in **Table 4-1** along with the average (AVG), standard deviation (STD) and coefficient of variation (CV). It can be seen that most of the CV for intact (IT) zone is smaller than 9% as required by ASTM C42. The CV for severely deteriorated (SD) area is significantly higher than 9% while the CV for moderately deteriorated (MD) zone lies in between. It is worth noting that due to the severe deterioration of the concrete foundation wall, some of the collected core samples are just a group of pieces of disintegrated aggregates with attached matrix (**Fig. 4.4**) thus the compressive strength of such samples are 0 MPa and the compressive strength reduction is considered as 100%. As summarized in **Table 4-1**, the compressive strength reduction of concrete foundation wall ranges from 27% to 100%.

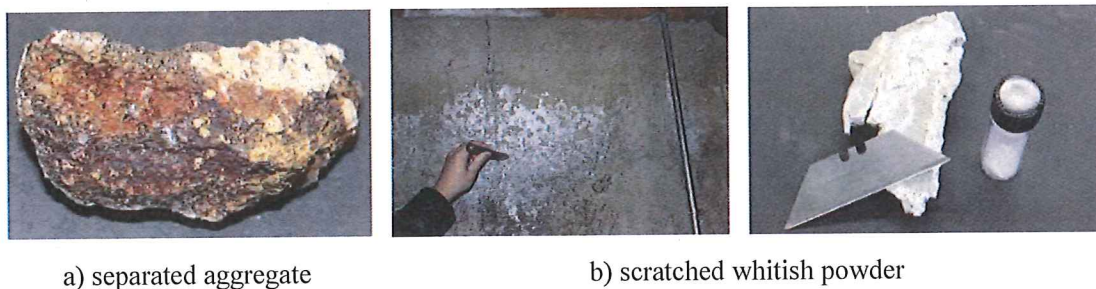
Fig. 6.1 Sample preparation for XRD testing

Brown aggregate, which is a sign of iron sulfide oxidation, were selected for this investigation. Aggregates were separated from cement matrix (Fig. 6.1a). Similar procedures described in section 5.1.1 were followed. The whitish formation was scratched off the surface of the deteriorated concrete foundation for XRD testing (Fig. 6.1b). All specimens were step-scanned as random powder from 11° to 80° at $0.02^\circ 2\theta$ steps integrated at 1 s step^{-1} .

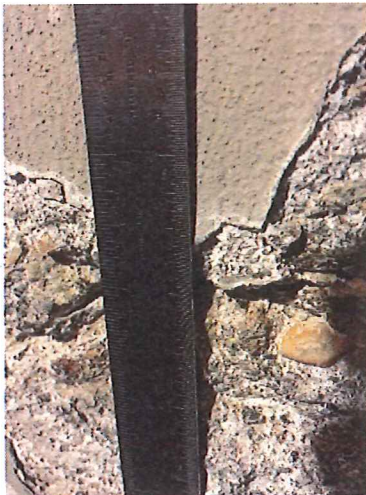
(d) wide crack opening

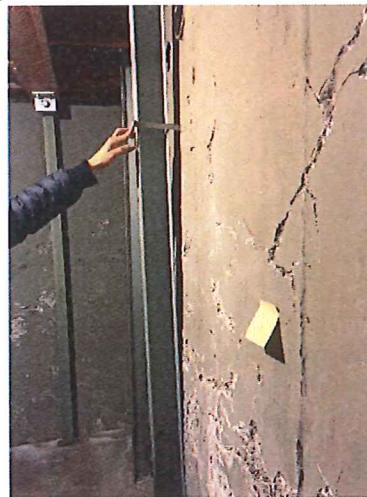
Fig. A- 1 House 1

(e) large deformation

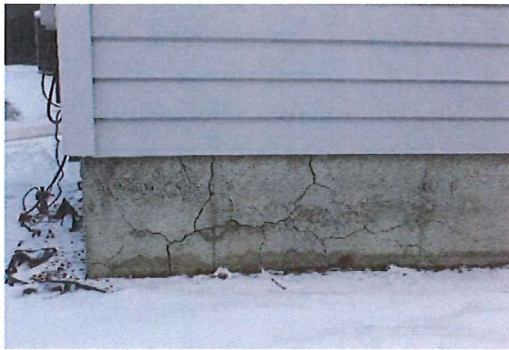
(c) map cracking

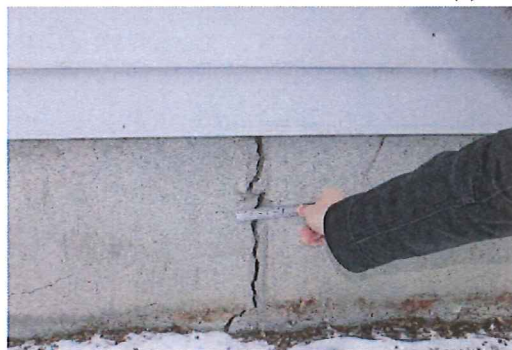
Fig. A- 3 House 3

(d) wide crack opening

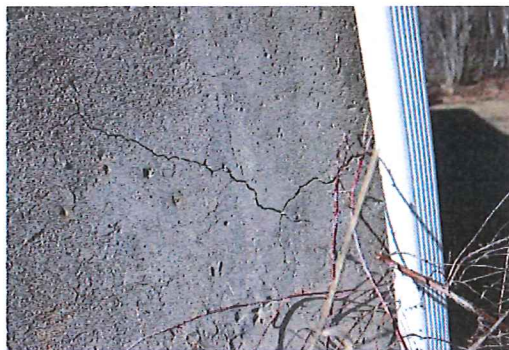
(c) map cracking

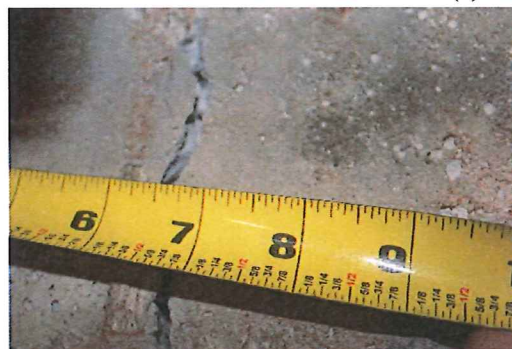
Fig. A- 4 House 4

(d) wide crack opening

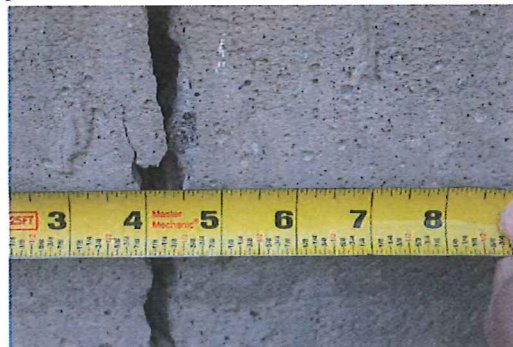
Fig. A- 5 House 5

(d) wide crack opening

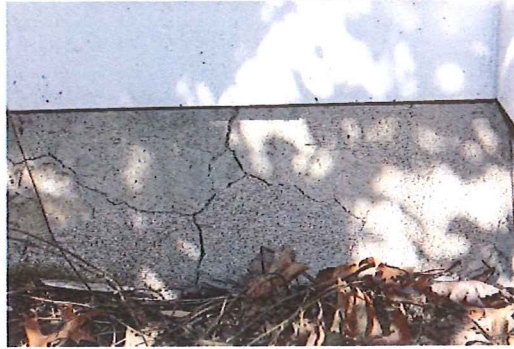
(b) map cracking

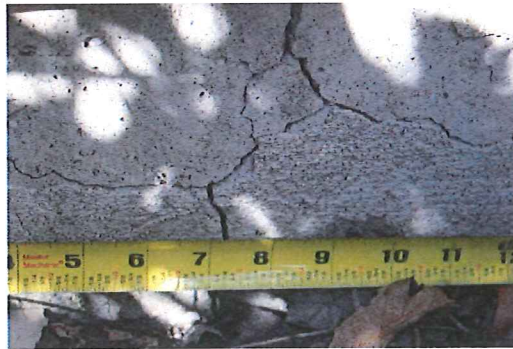
Fig. A- 6 House 6

(c) wide crack opening

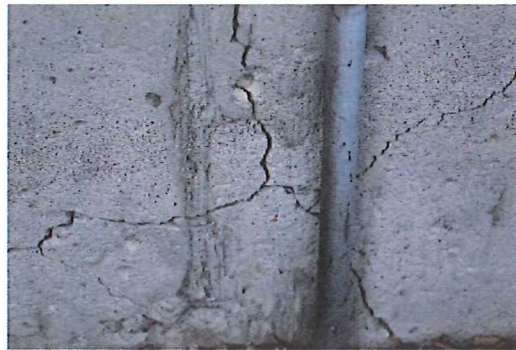
Fig. A- 7 House 7

(b) map cracking
