# **U. S. Route 5 Corridor Study**

## **Existing Conditions Report**

**Capitol Region Council of Governments**

**TranSystems Corporation**

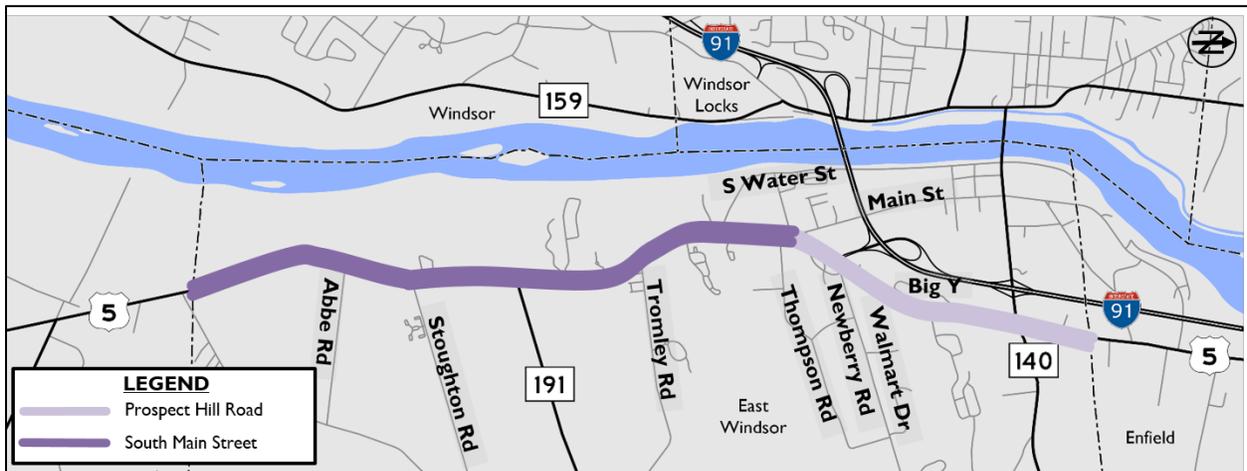
**Figure I: Route 5 Corridor Study Project Limits and Street Names**

The Study Area includes the corridor along Route 5 in East Windsor from the Enfield town line to the South Windsor town line, a distance of approximately five miles. From the southern limits of the corridor northerly to its intersection with Main Street, Route 5 is known as South Main Street. From Main Street northerly to the Enfield town line, Route 5 is known as Prospect Hill Road. The Study Area limits and street names are shown in **Figure I**. The Study includes the assessment of intersecting side street approaches, as well as access and egress for adjacent land uses. The Route 5 corridor includes highway exit and entrance ramps for Interstate 91 (I-91), residential streets, and several businesses. There are also many local destinations on or adjacent to Route 5 such as schools, restaurants, farms, retail, and grocery stores. Route 5 is served by infrequent bus service and provides limited amenities to bicyclists and pedestrians.

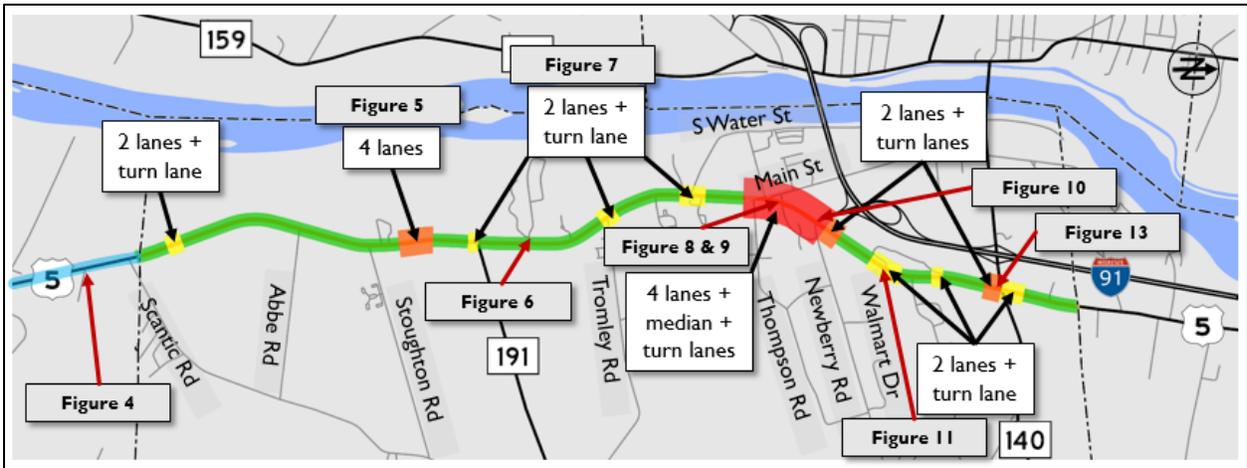
**Figure 3: Total Number of Lanes in the Study Area**

South of East Windsor, Route 5 has two lanes in each direction with a 25-foot-wide median and occasional turn lanes. The roadway continues southerly in this configuration to downtown East Hartford, a distance of approximately seven miles. Traveling north from South Windsor into East Windsor, Route 5 narrows to an undivided roadway with one through lane in each direction, as shown in **Figure 4**.

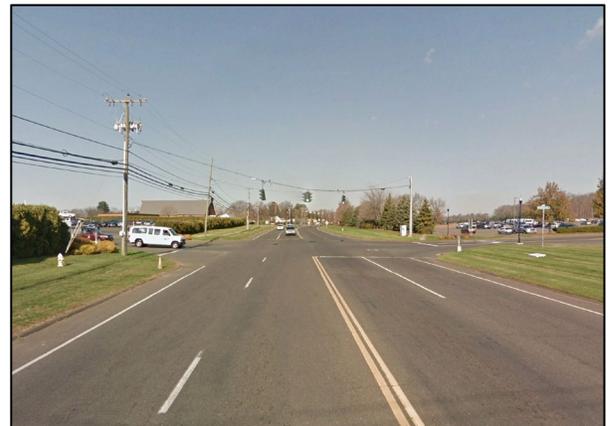
**Figure 5: Route 5 NB at Southern Auto Auction (Google Street View)**

Route 5 widens to two through lanes in each direction approximately 600 feet south of the traffic signal at Southern Auto Auction’s main driveway, as shown in **Figure 5**. This four-lane section continues another 600 feet past the signal. There is no median in this area.

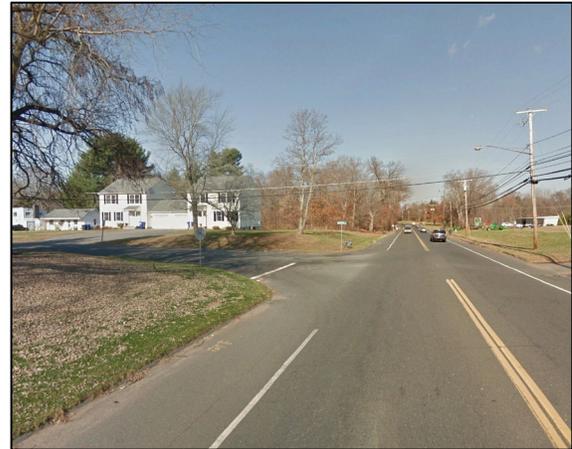
**Figure 6: Route 5 NB at Winton Road (Google Street View)**

Route 5 continues to the north with one through lane in each direction. On the 0.7-mile segment between Phelps Road (Route 191) and Tromley Road, there are multiple unsignalized intersections at driveways and side streets. One notable intersection is at Winton Road, a residential street serving as the sole access point for dozens of houses and condominiums. No turn lanes are provided. This intersection is shown in **Figure 6**.

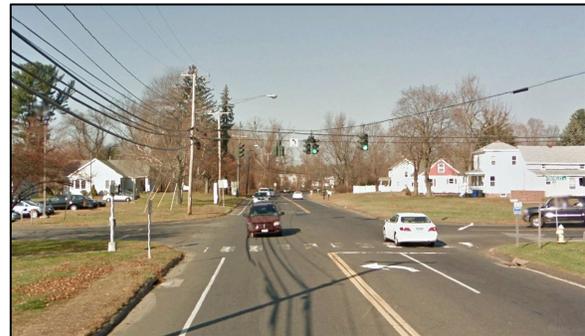
**Figure 7: Route 5 NB at Tromley Road and East Windsor High School (Google Street View)**

The next signalized intersection to the north is at Tromley Road and East Windsor High School, shown in **Figure 7**. This is the only traffic signal in the Study Area to have a marked crosswalk. Exclusive left turn lanes are provided in both directions on Route 5.

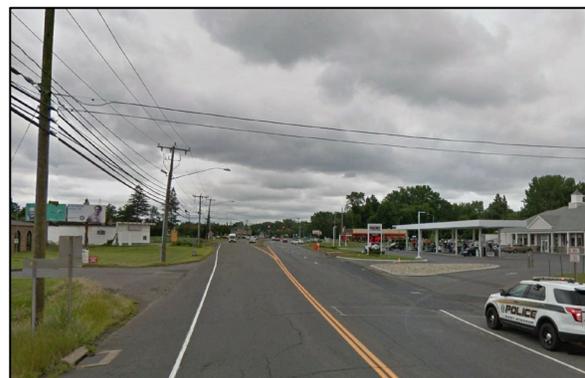
**Figure 8: Route 5 NB South of Thompson Road (Google Street View)**

A quarter mile to the north South Water Street intersection, the road cross-section rapidly changes. There are several closely spaced gas station driveways south of Thompson Road as Route 5 widens from a two-lane road to a much wider four-lane road with turn lanes and a raised median, shown in **Figure 8**. The complexity of this area has likely contributed to an increased crash rate relative to the surrounding segments. This increase in crashes is discussed in more detail in Section 2.1.3 - Crash History, page 20. The signalized intersection with Thompson Road has two through lanes northbound and southbound, plus a southbound exclusive left turn lane.

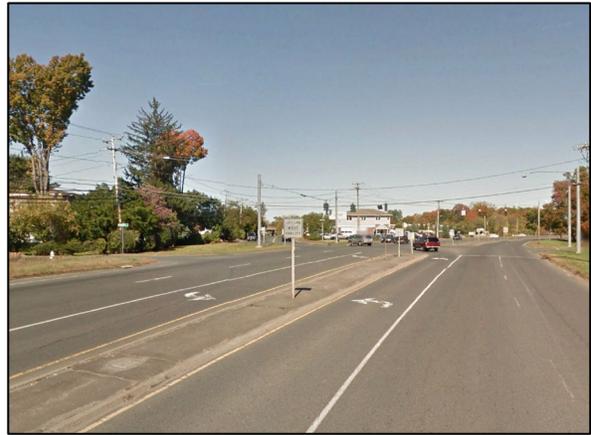
**Figure 9: Route 5 NB Between Thompson Road and Main Street (Google Street View)**

Between the signals at Thompson Road and Main Street, separated by 400 feet, is an unsignalized intersection with Wagner Lane which is only accessible from Route 5 southbound. Northbound traffic must perform a U-turn to get to Wagner Lane. This area is shown in **Figure 9**. The traffic signal at Main Street (unsigned Route 510) runs off the same controller as the signal at Thompson Road due to their proximity. Route 5 has three lanes in each direction here – two through lanes and an exclusive left turn lane.

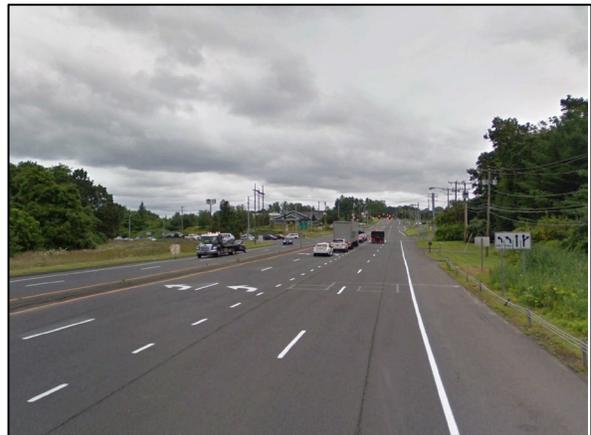
**Figure 10: Route 5 NB Approaching the I-91 Exit 44 Ramps (Google Street View)**

Continuing north, Route 5 gains more lanes as it approaches the I-91 Exit 44 ramps. This is shown in **Figure 10**. Route 5 northbound has two through lanes and two exclusive left turn lanes. Route 5 southbound has two through lanes and exclusive left and right turn lanes. There is no raised median north of the intersection, only occasional painted islands. Crash rates at this intersection are significantly higher than other intersections in the Study Area.

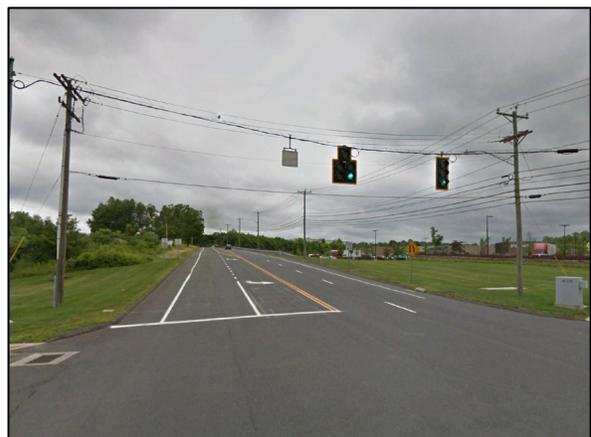
**Figure 11: Route 5 NB at Walmart (Google Street View)**

Approximately 500 feet north of the I-91 ramp intersection is another traffic signal serving Walmart on the east side of Route 5 and two restaurants and a bank on the west side. This is another area of transition – Route 5 narrows from two through lanes in each direction to one. At the traffic signal, Route 5 northbound has two through lanes and exclusive left and right turn lanes; the two through lanes merge just north of the intersection. Southbound, Route 5 has one through lane and one exclusive left turn lane. This merge is shown in **Figure 11**.

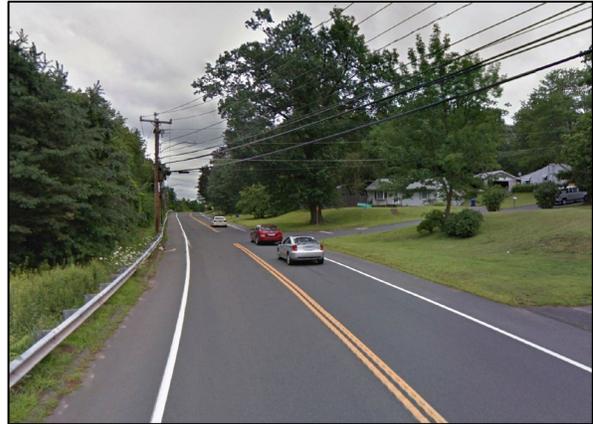
**Figure 12: Route 5 NB Approaching Prospect Hill Drive (Google Street View)**

750 feet north of this signal is an unsignalized intersection with Prospect Hill Drive, a residential street serving over 100 houses. This intersection is shown in **Figure 12**. No exclusive turn lanes are provided on Route 5.

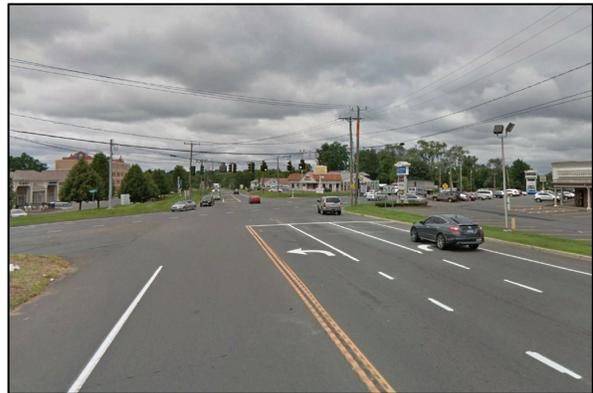
**Figure 13: Route 5 NB at Bridge Street / North Road (Google Street View)**

The final signalized intersection in the Study Area is at Bridge Street / North Road (Route 140), shown in **Figure 13**. Route 5 widens near this intersection to one through lane in each direction, exclusive left turn lanes in each direction, and a northbound exclusive right turn lane. The intersection itself is skewed with steep grades on its approaches, and it is a complex area due to the surrounding development and numerous driveways. Crash rates here are higher than at most other intersections in the Study Area.

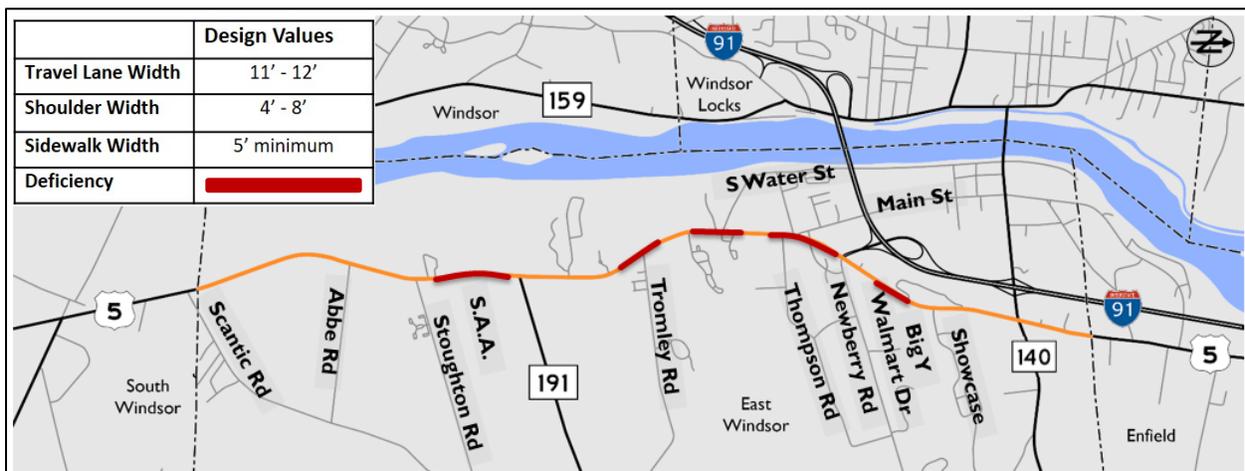
**Figure 14: Locations of Deficient Shoulder Widths**

Roadway shoulders within the Study Area range from nonexistent to over six feet. Shoulders are used as bypass lanes for through traffic to get around vehicles waiting to turn left or right; where shoulders are narrow or absent, this is not possible. **Figure 14** highlights locations with deficient shoulder widths.

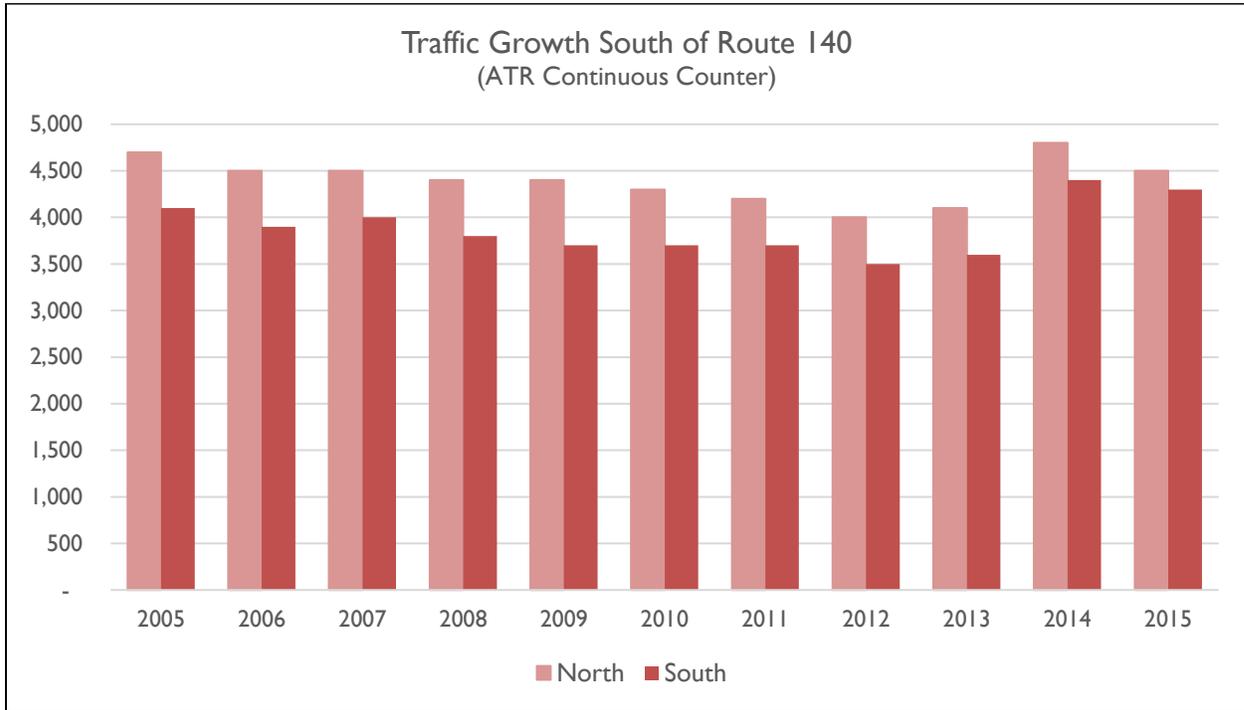
**Figure 15: CTDOT Continuous Count Station Volumes by Direction**

Traffic growth at the continuous count station has been variable, slowly decreasing between 2005 and 2013. The Walmart just south of the continuous count station was opened in late 2013. Bidirectional traffic volumes at the continuous count station increased from 6,900 in September 2013 to 9,800 in November, 2013.

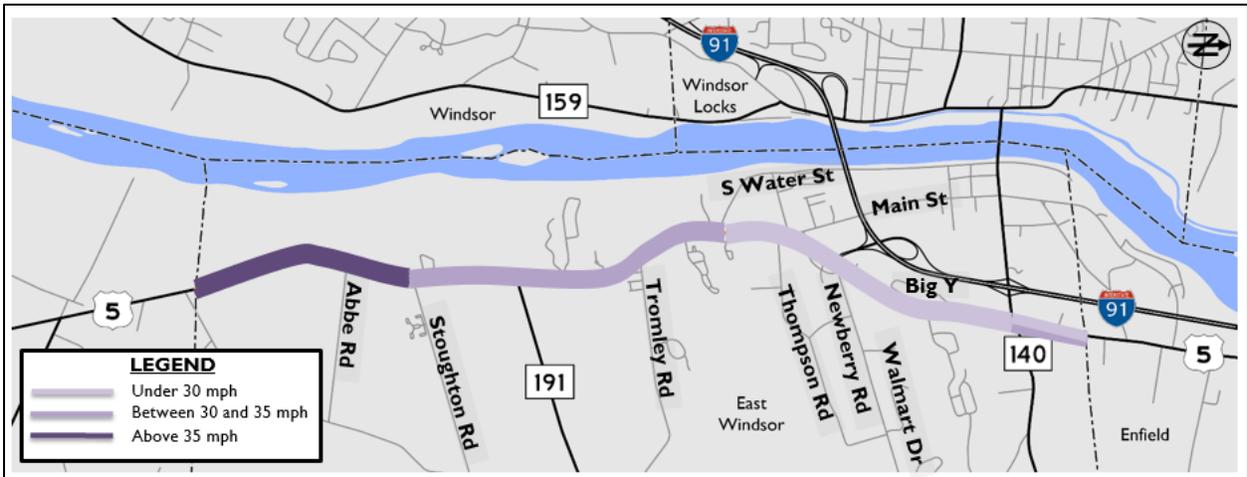
**Figure 18: FHWA NPMRDS Average Travel Speeds along U.S. Route 5**

Between Scantic Road and Stoughton Road, the average travel speeds are approximately 35 mph and are the highest observed within the study area. From Stoughton Road in the northern direction, the average speeds degrade to between 35mph and 30mph until South Water Street; farther north the speed decrease even further to under 30mph.

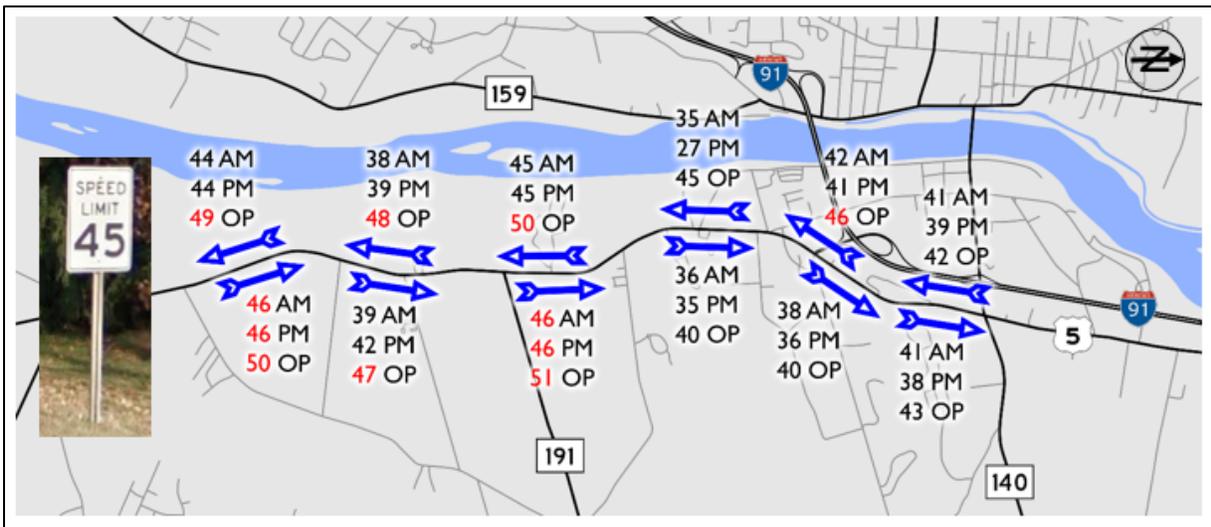
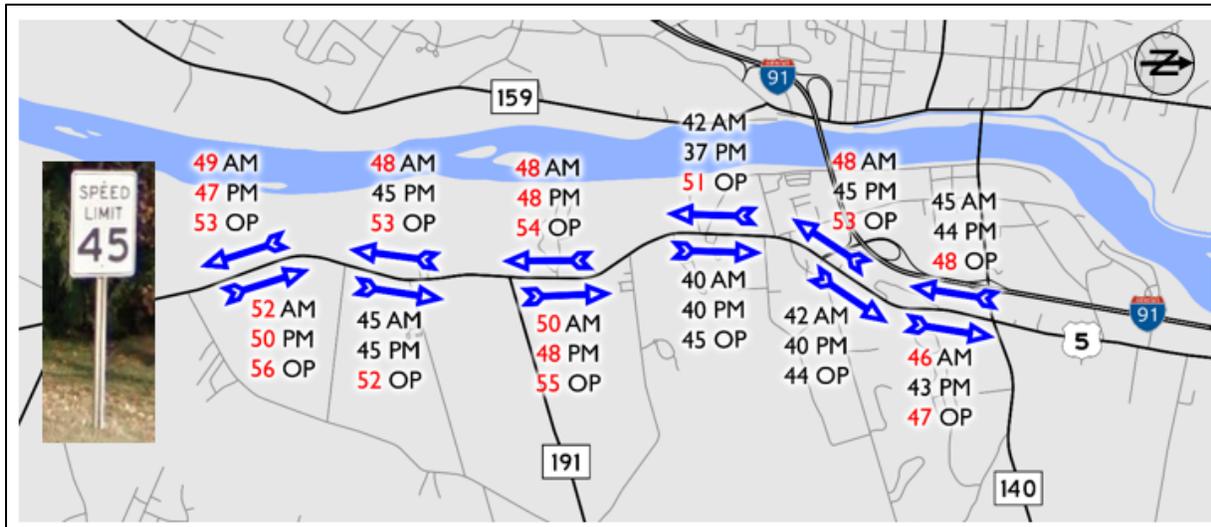
**Figure 19: Average Weekday Segment Speeds (AM, PM, Off-Peak)**

**Figure 20: 85th Percentile Weekday Segment Speeds (AM, PM, Off-Peak)**

The spot speed data between larger segments of roadway without traffic signals shows vehicles traveling at or above the speed limit during off peak, highlighted in red. Similar to the FHWA data, speeds are lower north of Tromley Road throughout the day and in both directions. This delay may be caused by several factors, including high volumes, queues at traffic signals, vehicles turning at unsignalized intersections, heavy vehicles, and bus stops without pullouts.

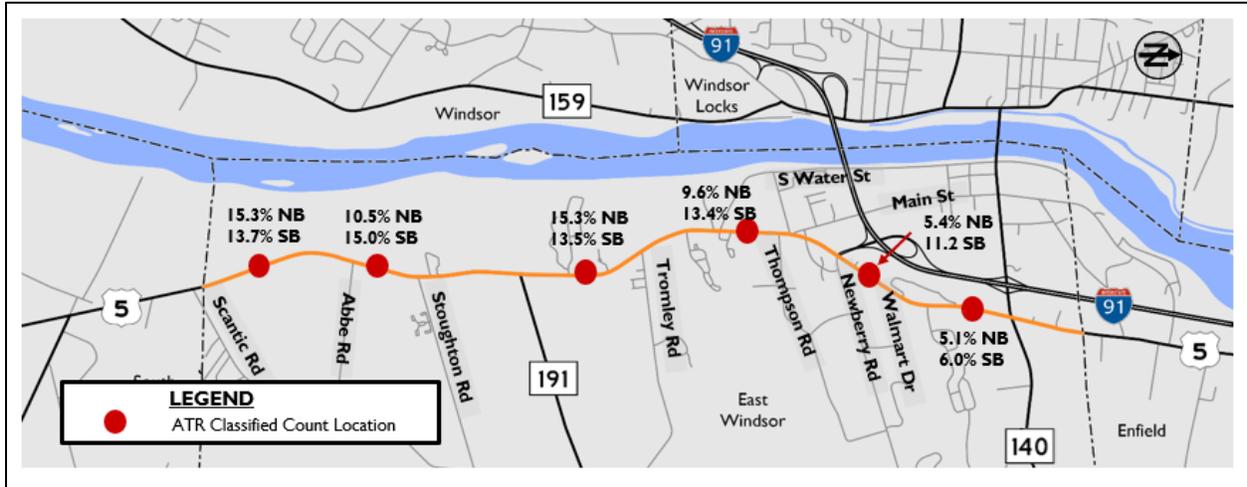
Figure 23: Heavy Vehicle Traffic Percent by Direction

ATR data collected by the study team in 2018 shows that heavy vehicles, including trucks and buses, comprise 5% to 16% of the daily traffic volumes on Route 5, as illustrated in **Figure 23**. The highest heavy vehicle percentages are south of the I-91 Exit 44 ramps, where 9% to 16% of vehicles are trucks or buses. This is largely due to the major commercial and industrial uses on this stretch of Route 5 and the adjacent section in South Windsor. Every year, the Connecticut DOT posts vehicle classification reports. Based on 2018 data, other non-interstate principal arterials experience on average 3% to 7% of trucks and buses. **Table 4** provides a sample of site location, comparable AADTs and percentages of heavy vehicles.

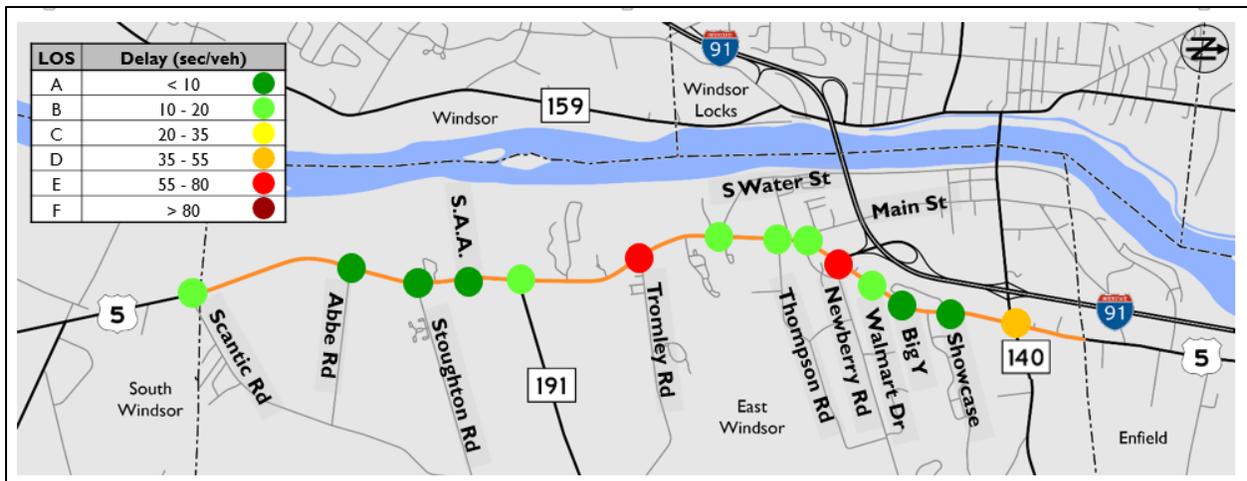
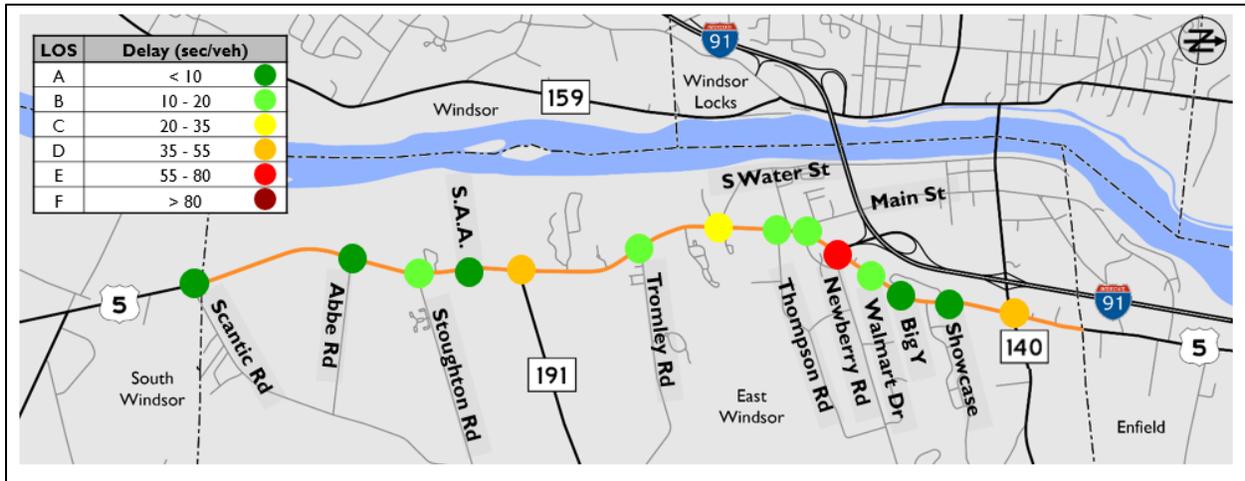
Figure 24: AM Peak Level of Service (LOS) for Study Intersections

Figure 25: PM Peak Level of Service (LOS) for Study Intersections

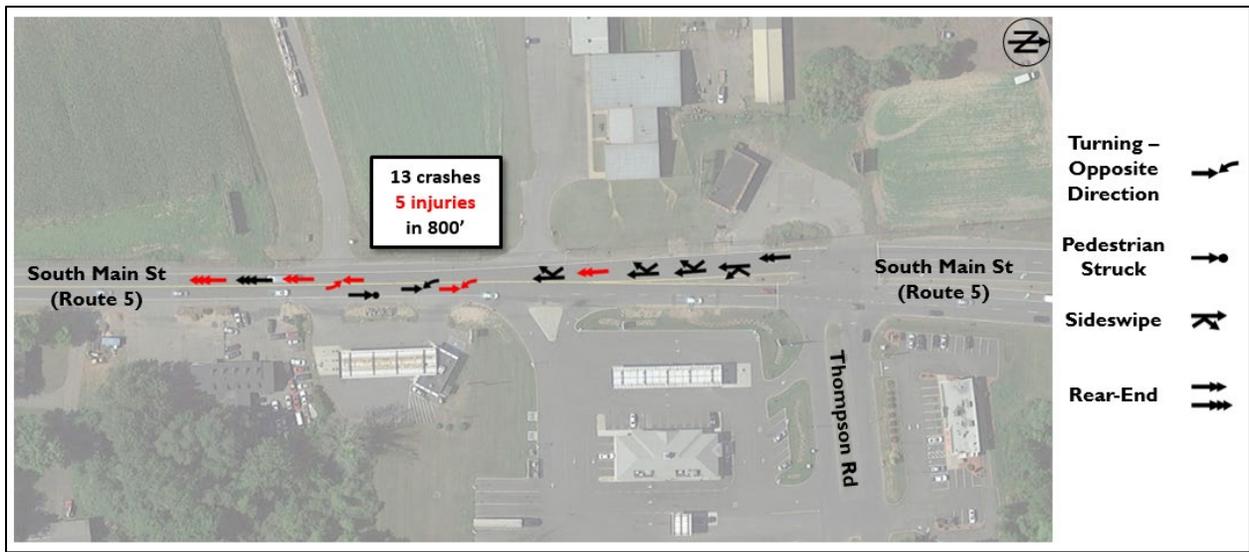
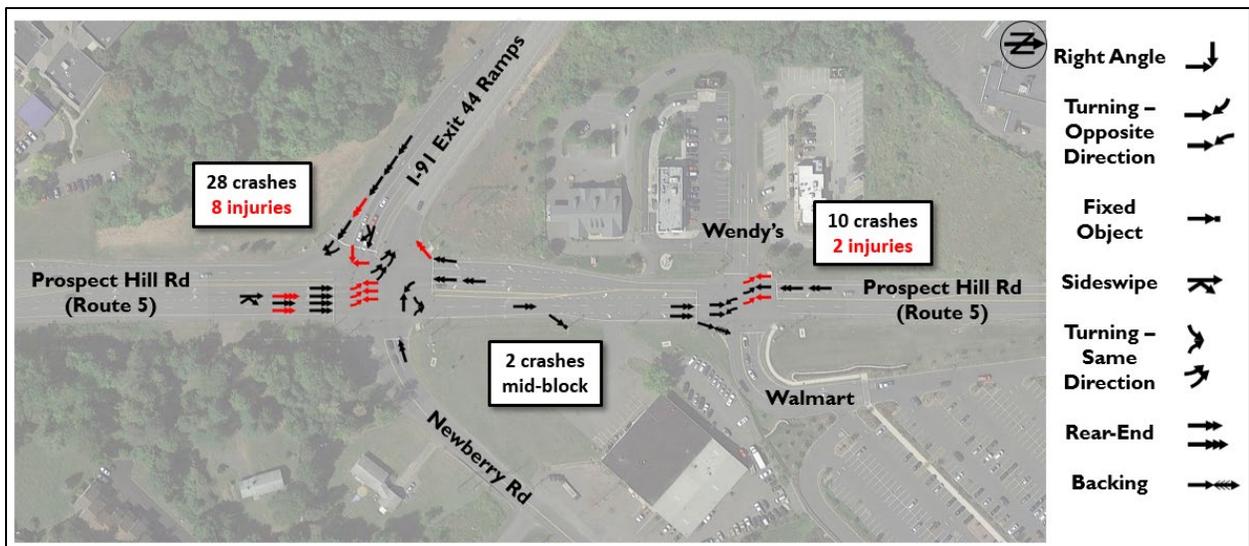
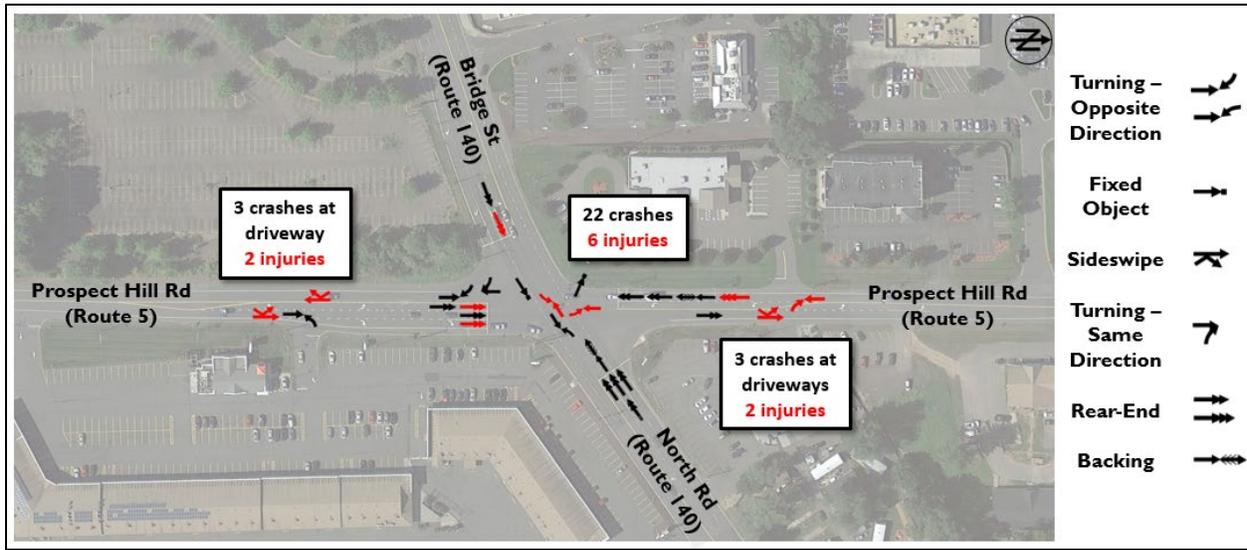
Figure 26: High Crash Location 1: Segment South of Thompson Road

Figure 27: High Crash Location 2: I-91 Exit 44 and Walmart Intersections

**Figure 28: High Crash Location 3: Bridge Street / North Road (Route 140) intersection and adjacent driveways**

- Nearly half of crashes were rear-ends, a common collision type attributed to vehicles following too closely.
- Approximately 10% of crashes involved sideswipes, attributed to improper passing maneuvers or improper lane change, and generally clustered around merges.
- Approximately 12% of crashes involved angle crashes, attributed to turning vehicles failing to yield the right-of-way, and generally resulting in more severe injuries.
- At the I-91 Exit 44 ramps, left turns are protected-only; however, there were still several angle crashes between left-turning and through vehicles, indicating a potential red-light-running problem.
- Route 5 is listed in the top 10 state routes with highest overall injury rate and severity for crashes.
- There were no fatalities on Route 5 within this three-year period.

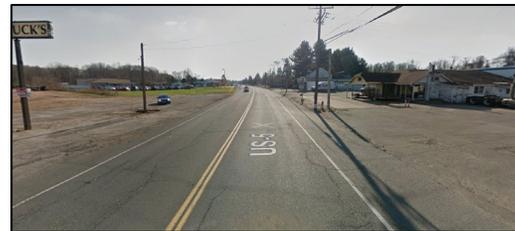
*Large Curb Cut & Undefined Driveway*

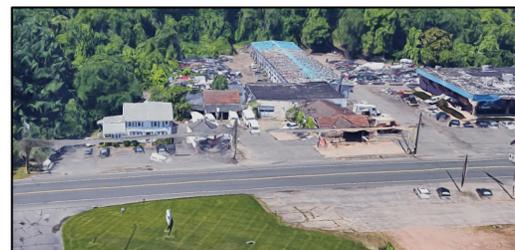
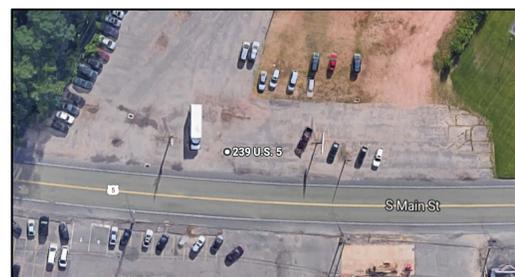
*Adjacent Commercial Driveways and Wide Curb Cut (239 / 248 US-5)*

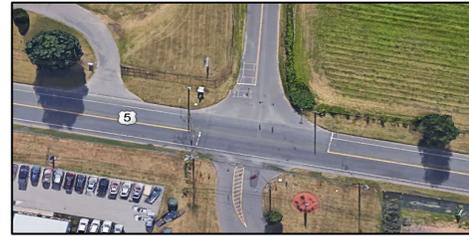
The access management deficiencies in this segment pertain to the proximity of adjacent commercial driveways, closely spaced driveways, including at signalized intersections, and redundant driveways. Businesses should not have more driveways than are required to maintain site access and operations.

**Close Driveway to Signalized Intersection (Abbe Road)**

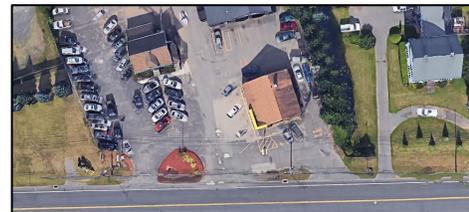
**Adjacent / Shared Commercial Driveways and Wide Curb Cut (140 - 142 S. Main St.)**

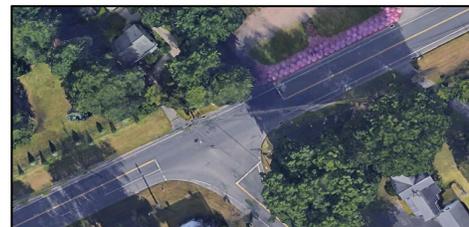
**Residential Driveway across from signalized intersection (134 S. Main St.)**

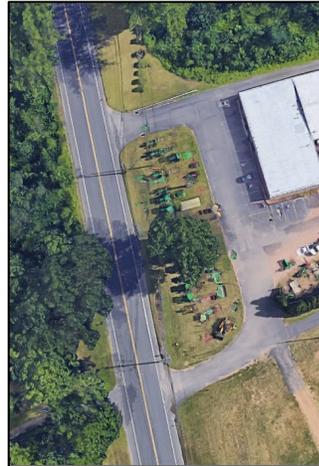
The 0.8-mile segment of Route 5 from Tromley Road to Thompson Road has left turn lanes at the intersections with South Water Street and Thompson Road. There are redundant two-way drives and adjacent closely spaced commercial driveways.

**Redundant Driveway  
(107B S. Main St)**

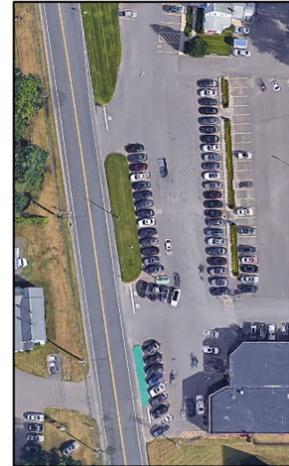
**Redundant Driveway  
(82 S. Main St)**

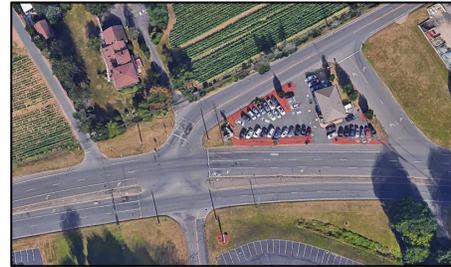
Access management principles are more closely followed in this area, with greater spacing between access points and fewer redundant driveways. However, there is a greater number of driveways around the intersection of Route 5 and Bridge Street / North Road (Route 140), with driveways less than 250 feet from the traffic signal on all approaches. Residential driveways are closely spaced as well.

**Close spacing between access to  
Wagner Ln and Main St**

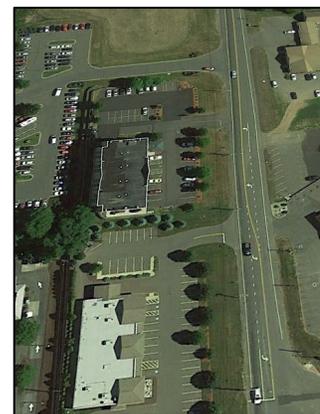
The access point to Comfort Inn is located approximately 400 feet from Bridge Street / North Road (Route 140). The Cracker Barrel Old Country Store access point is another 100 feet to the north. The Comfort Inn has dedicated left turn lane for vehicles coming from the south, however Cracker Barrel Old Country Store does not. This location could benefit from driveway consolidation.

**High volume left turn  
access to Cracker Barrel  
Old Country Store**

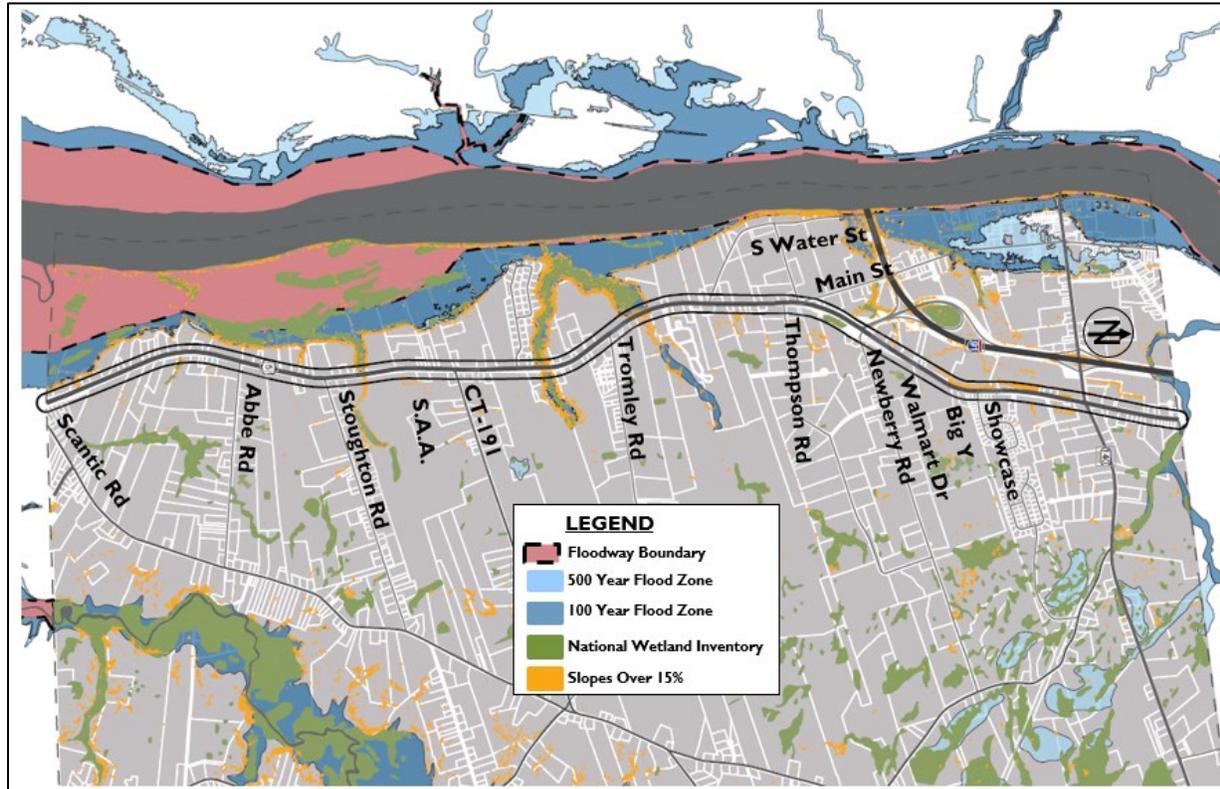
**Figure 32: Environmental Constraints**

**Figure 32** illustrates the approximate boundaries of 100-Year Flood Zone, 500-Year Flood Zone, and wetlands. The 100-Year Flood Zone is the area that has a one percent chance of flooding in any given year. In the southern end of the Study Area, much of the land adjacent to Route 5 is within the 100-Year Flood Zone.

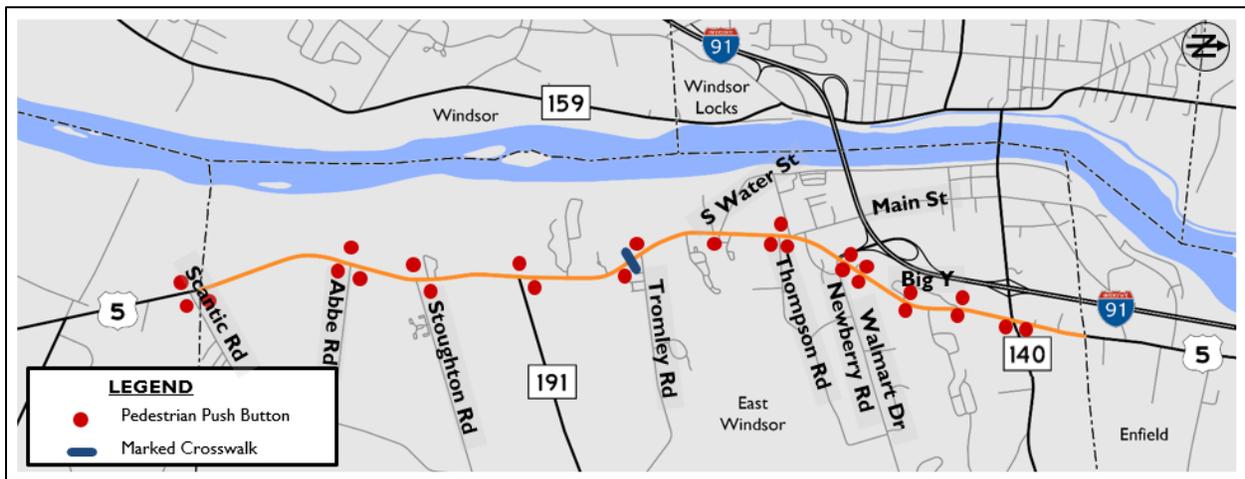
**Figure 34: Pedestrian Facilities**

Being rural in nature, the study corridor generally has no sidewalks. Other pedestrian facilities are limited to incomplete sets of pedestrian actuated intersection crossings and a single painted crosswalk across Route 5. The locations of these facilities are noted in **Figure 34**. The crosswalk is located at Tromley Road and East Windsor High School. There are a number of pedestrian push buttons along Route 5 in the Study Area. Many of these push buttons are not accessible to people with disabilities. Only the push button at Tromley Road actuates an exclusive pedestrian phase; the remainder are side-street green.

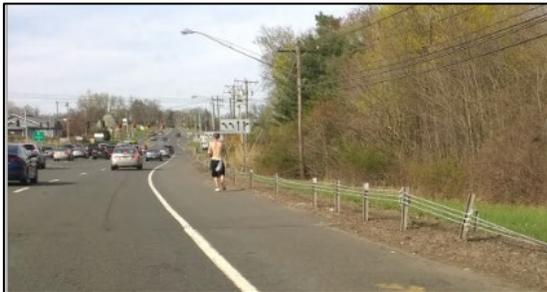
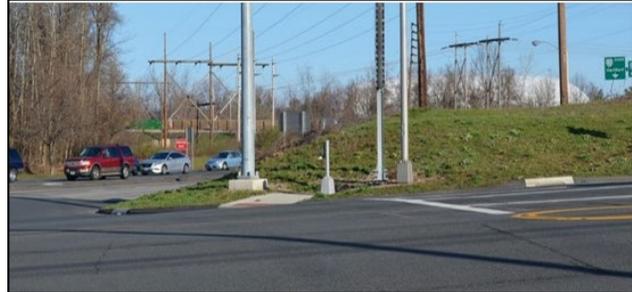
Pedestrian Walking in Shoulder Lane (44 South Main Street) Push-to-Walk Button at Newberry Rd Interchange

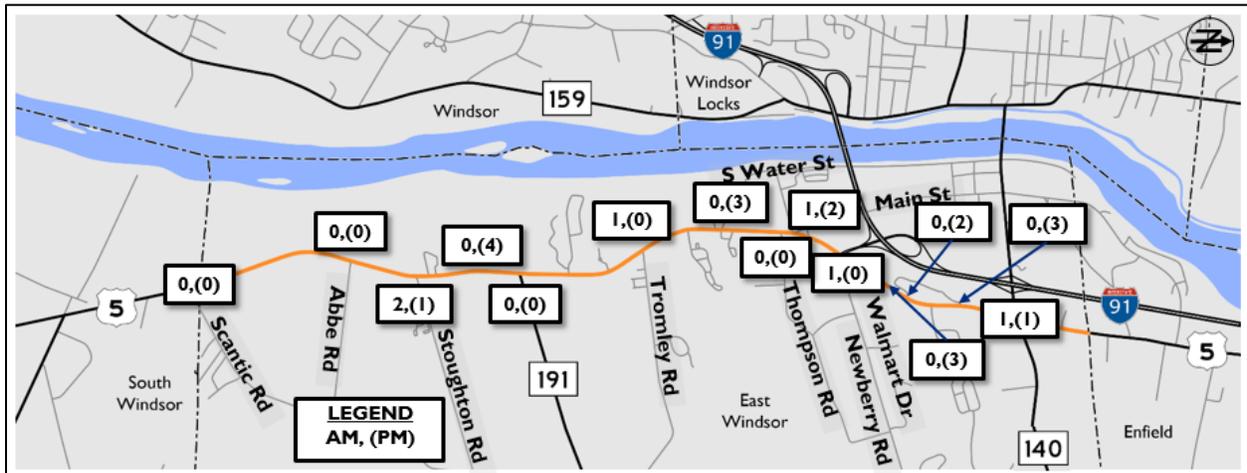
Figure 35: Pedestrian Counts at Intersections AM, (PM)

Figure 35 shows the number of pedestrians counted at signalized intersections corridor during the AM and PM peak periods. There are signs of pedestrian presence in the corridor such as goat paths on the side of the road. Pedestrians may walk in the shoulder where there is vegetation, a slope, or other barriers along the edge of the road. In general, roadway shoulders of varying width are provided on both sides of the corridor. These shoulders are utilized by motorists for passing turning vehicles, cyclists in lieu of bike lanes, and pedestrians. It should be noted, at some locations the shoulders are absent altogether.

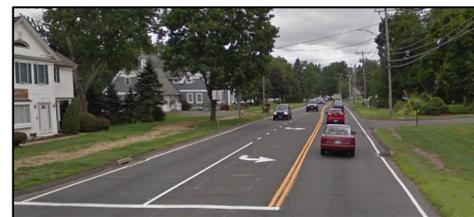
Goat Path & No Shoulders (Right Side, 34 South Main Street)

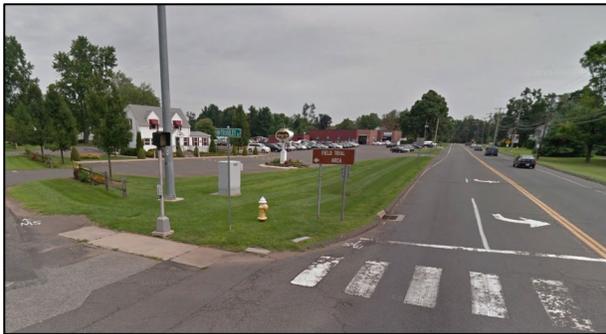
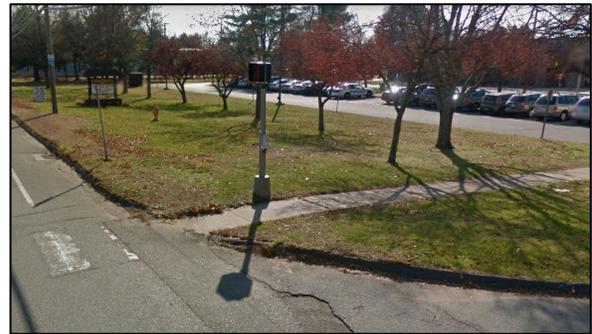
The single marked crosswalk at Tromley Road does have push buttons, but there are no other amenities typical of a pedestrian corridor, e.g., tactile warning strips, continuous sidewalk on the east side of the corridor, audible or vibrotactile pedestrian signals, and properly designed ramps with curb and gutter considerations. The crossings at this locations may be difficult to navigate for vulnerable users.

*Tromley Road sidewalk condition and ADA non-compliance*

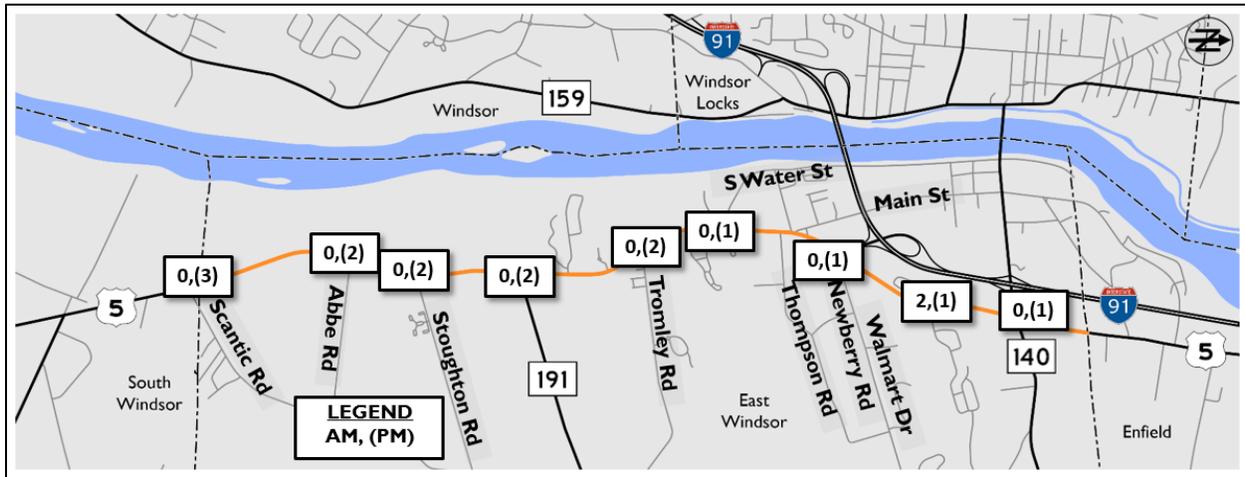
Figure 39: AM and PM Bicycle Counts

Data collection efforts confirm that there are a few minimal bicycle riders on the corridor during peak periods. Bicycle counts at signalized intersections are shown on **Figure 39**, Page 38. Though the number of bicyclists is low, they travel through multiple intersections, showing that there is demand for medium- and long-distance bicycle travel along Route 5.

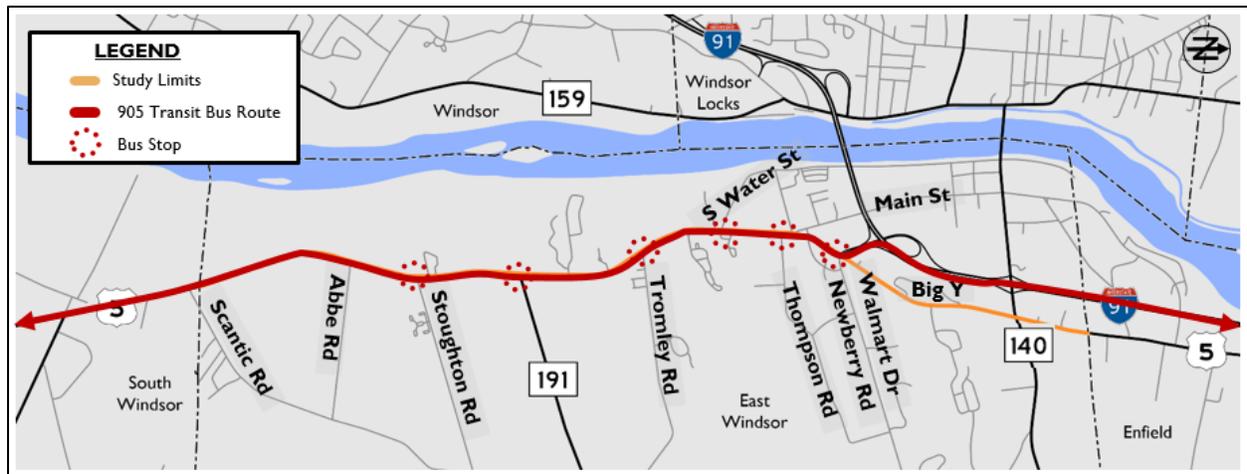
Figure 40: 905 Bus Route in Study Area

Connecticut Transit (CTtransit), a CTDOT-owned bus service, provides bus service to downtown Hartford on weekdays from Enfield and South Windsor. Within the Study Area, only route 905E traverses the corridor, and it does so in the off peak direction. In the AM, the peak travel direction is to Hartford; however, the 905E traverses Route 5 is in the northbound direction towards Enfield, allowing only disembarkments. In the evening, the reverse is true, and the bus only accepts embarkments as it heads down Route 5 towards Hartford. These are the only two CTtransit buses on Route 5 on weekdays, and there is no bus service on weekends. Figure 40, page 39 outlines route 905 and designated stops. On Route 5, bus stops are marked with an official bus stop sign; Figure 41 on page 39 provides examples.

Route 905 ridership averages approximately 960 trips per day on its peak direction route, but only seven to ten riders on its off-peak service down Route 5. While majority of the trips in the off-peak direction are through trips, 2-3 riders embark or disembark at Phelps Street (Route 191) and / or Stoughton Road.
