**NW Corridor Transit Planning
Union Station Existing Conditions
Technical Memorandum
(Physical and Operational
Assessments)**

**Capitol Region Council of
Governments**

October 24, 2007

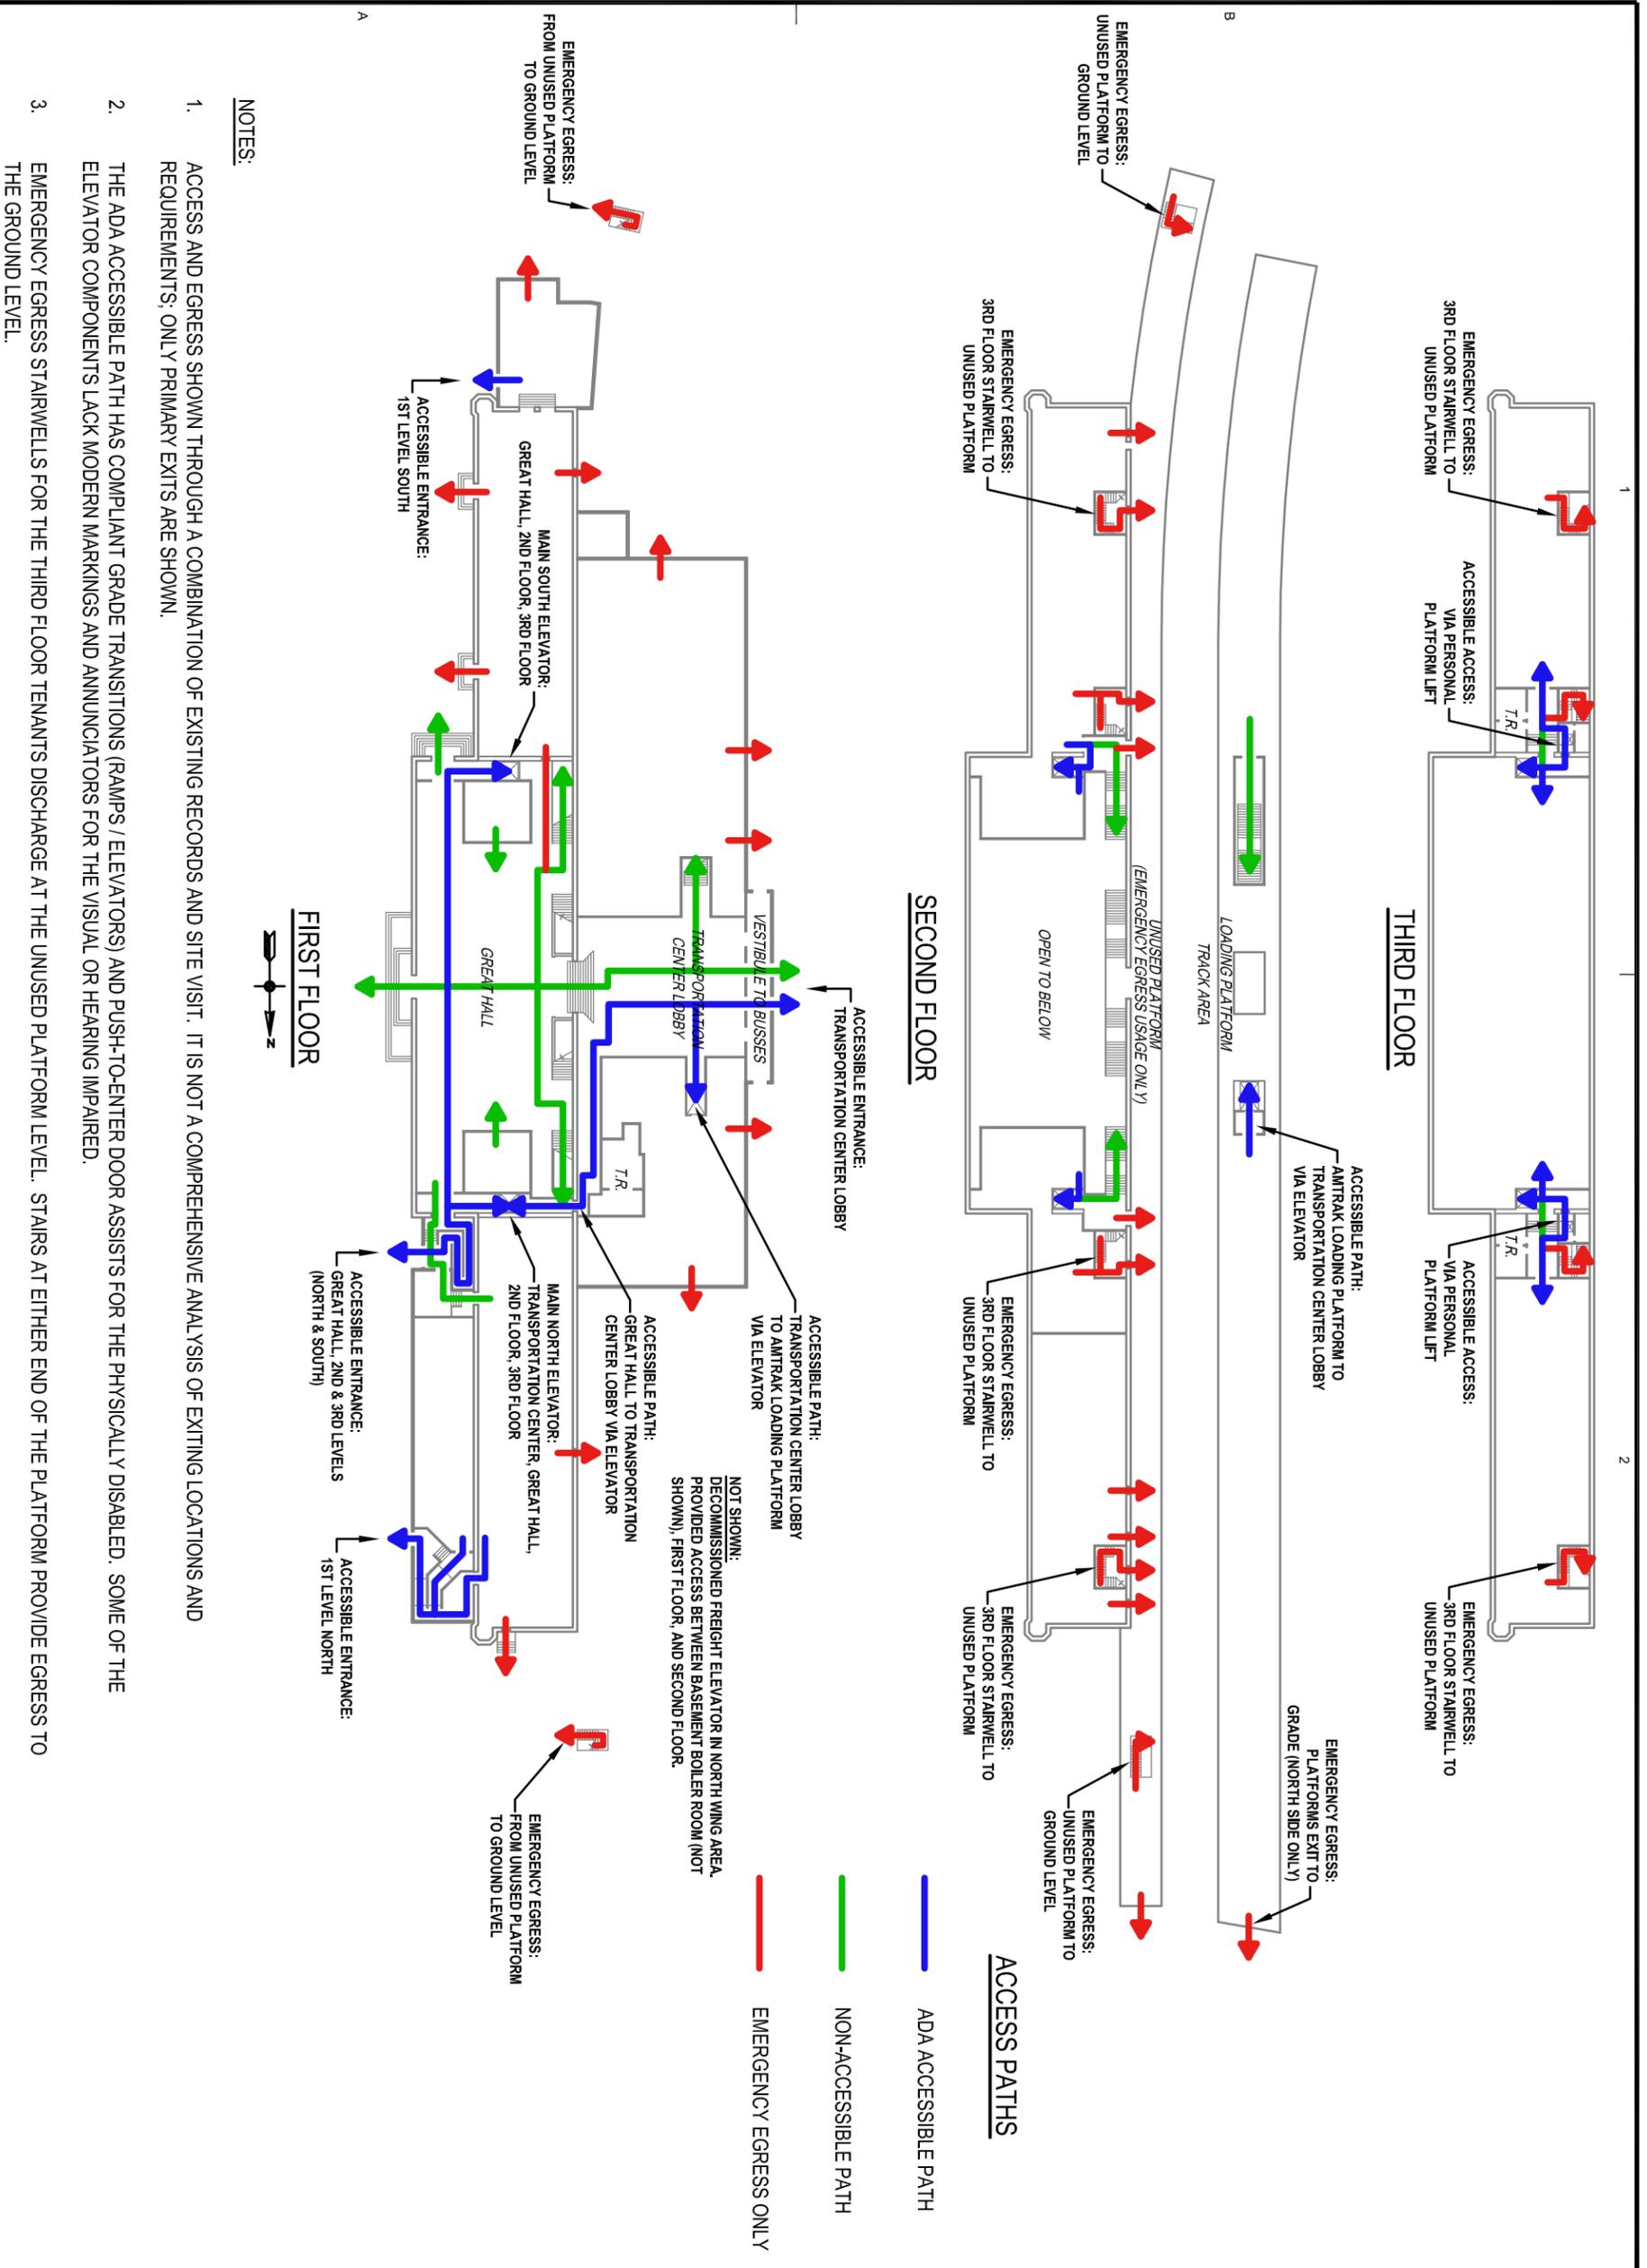
PROJ NO: P701060067 SCALE: NTS DATE: 08/20/07 DESIGNED BY: BJL DRAWN BY: BJL CHECKED BY: BJL	SHEET TITLE <h2 style="text-align: center; margin: 0;">EXISTING ACCESS PLAN</h2>																
<h1 style="margin: 0;">FIGURE 3</h1>

Figure 3 – Existing Access Plan also provides information relative to the non-accessible access into and thru the structure for both emergency and general purposes.

- In general, it is very good. The only exception is the not-leased space on the northern wing of the second floor.
- Accessible access for the disabled is provided to all areas with the exception of the second floor vacant space. Increased signage should be provided for the accessible route from the Great Hall to the Ground Transportation Center lobby. During routine upgrades, visual and auditory announcers should be placed in all elevator cabs and vestibules. Coordination should be made with all appropriate officials to confirm the final requirements for access improvements within the historic nature of the structure.

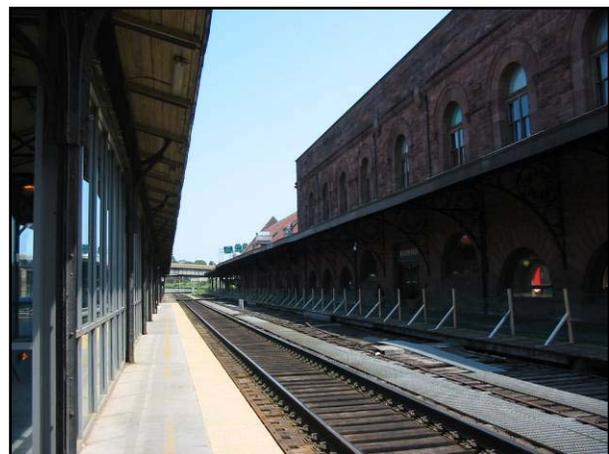
Photo 21 – Amtrak Train Platform showing Tactile Warning Strip

The only area of accessibility concern is on the loading platform for Amtrak. As discussed previously, while a tactile warning strip is present for a portion of the platform, loading and unloading operations were observed to occur in an area without the tactile strip.

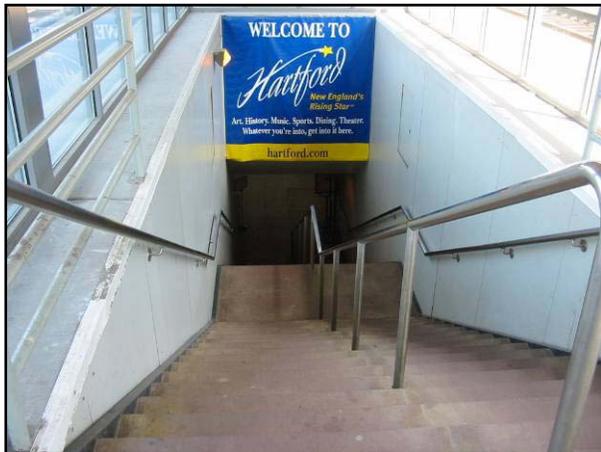
For the third floor, public access is only provided by either the north or south elevator. Emergency egress from the third floor is through main stairwells on the east side of the building, which exit onto the Amtrak platform. At either end of the platform are a set of stairs down to ground level. As discussed later in the report, these final stairwells from the Amtrak platform to grade show significant potential for structural deficiency and should be replaced immediately.³

³ Amtrak did close the stairwells at one time because of the structural issues. However, total closure is not feasible because of their purpose as emergency egress from the second and third floors and the GHTD petitioned to have them reopened. Some repairs were made but total replacement is recommended for safety purposes.

Photo 24 – Stairwell from to Ground Transportation Center Lobby from Amtrak Platform

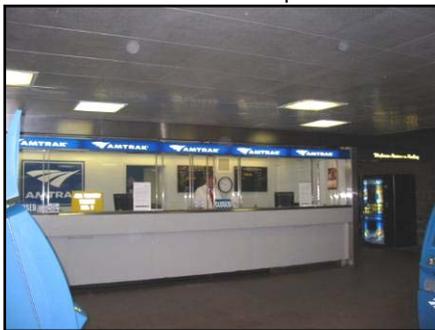
Any building is required to have all public amenities and areas accessible for the disabled. In general, most areas are compliant, if dated. All toilet rooms inspected are accessible. The ticketing counters are not compliant; however it is possible for a wheelchair customer to receive services. The waiting area does not provide specific handicapped seating. There are a bank of public phones, with one mounted at accessible height. It does lack the required accessible shelf and outlet for portable text telephone device.⁴ Some of the required distances from door jamb to adjacent wall were insufficient, but this is common in all structures completed before the more comprehensive ADA act of 1990.

Photo 28 – Amtrak Ticketing Counter

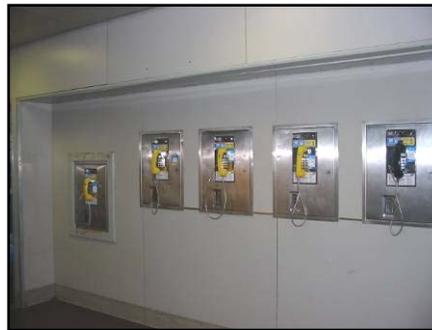
- Ticket counters and public phones are not fully ADA compliant, though a wheelchair user can receive service at the counters as well as use one of the public phones.

Photo 29 – Public Phones

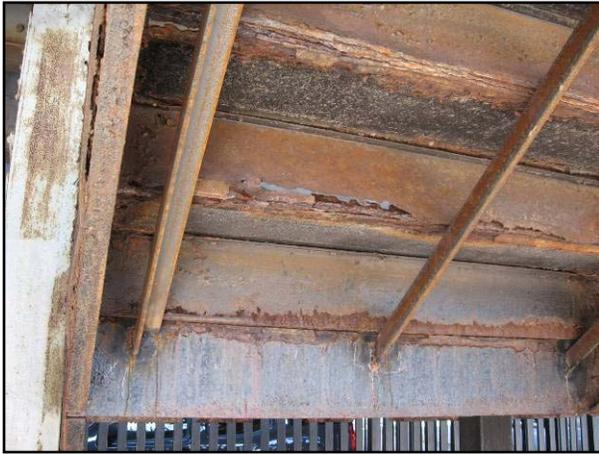
- The steel-framed stairs on the north and south ends of the central platform that are used for emergency egress from the second and third floors of Union Station are significantly rusted (see Photos 30 and 31). Supplementary angle framing has been added to the underside of the steel riser/tread pans apparently in an effort to strengthen the steps. The load carrying capacity of the steps has obviously been compromised. We consider the condition of the stairs a safety concern and recommend that the stairs be closed and repairs initiated immediately. According to GHTD, the City of Hartford's Fire Marshall and Building Inspectors offices have also noted these deficiencies and Amtrak is aware that they may be receiving written notification or be cited for safety violations within their leasehold area.

Photo 30 – Underside of Steel Stairs Serving East Platform

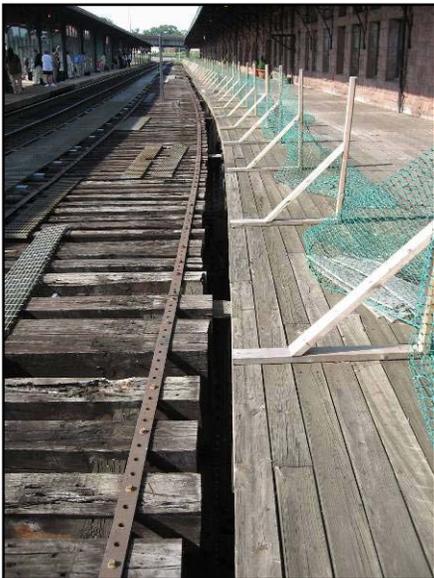
- Several older, unused rail ties adjacent to the east platform are missing or highly deteriorated (see Photo 32). This creates gaps between the ties where a person could conceivably fall to the ground below or to the roof of the Ground Transportation Center. Amtrak has installed a temporary wood-framed and plastic mesh fence in an effort to create a protective barrier for pedestrian at the edge of the platform. It is our opinion that this fence system is not robust enough to serve as a safety barrier. Additionally, certain sections of the plastic mesh have become unattached from the supporting wood posts allowing access to the edge of the platform. We consider this condition along the edge of the platform a safety concern that should be addressed immediately.

Photo 32 – View of East Platform and Adjacent Rail Ties

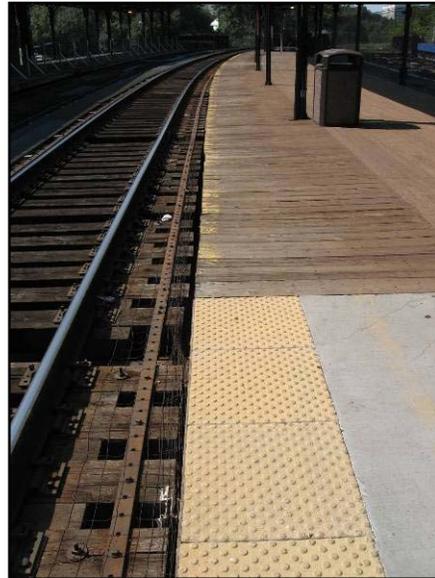
- There are several significant gaps between ties and between the edge of platform and ties on the east edge of the central platform. It is conceivable that a person could step through one of these openings if they were to step off the platform. Steel wire mesh has been added in some locations between ties in an effort to mitigate this situation, but gaps still exist in several locations (see Photo 33).

Photo 33 – View along Central Platform showing Rail Ties and Wire Mesh Enclosure

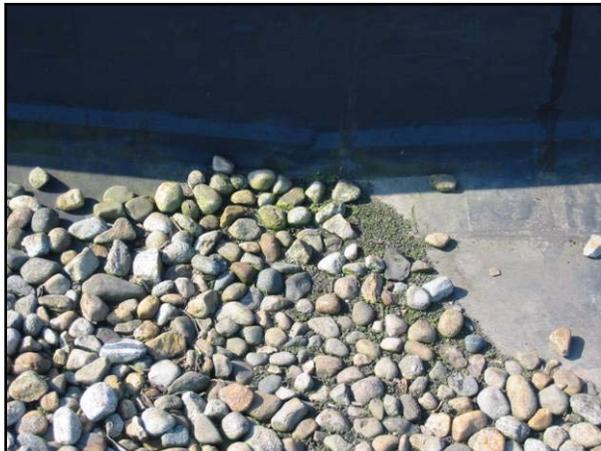
Photo 40 – Low Area at Beginning of Water Path Showing Sediment Collection and Moss, Evidence of Pooling Water

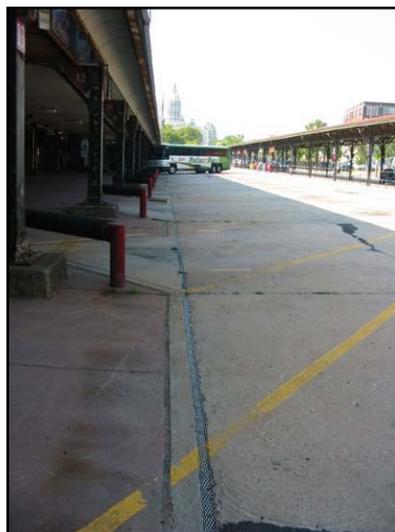
Photo 44 – Trench Drain at Bus Stalls

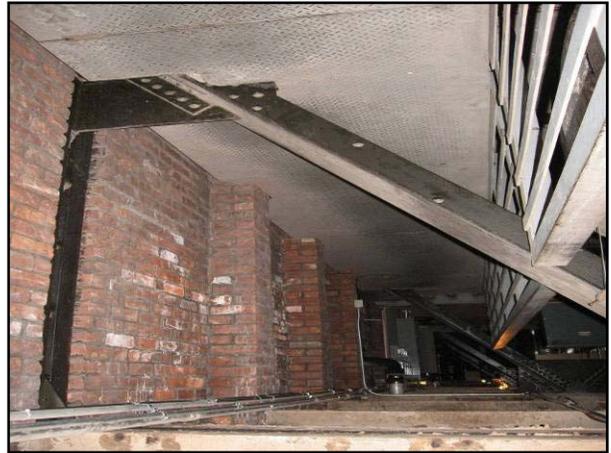
Photo 46 – Brick Facing, Interior of Brownstone Bearing Wall in Attic above Great Hall

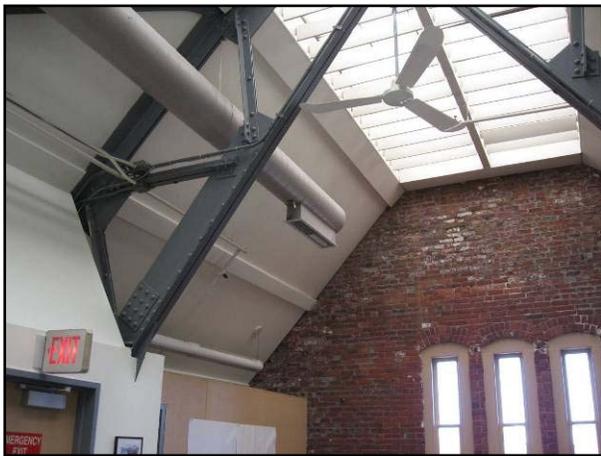
Photo 47 – Interior of Brownstone Bearing Wall in 3rd Floor Lease Space

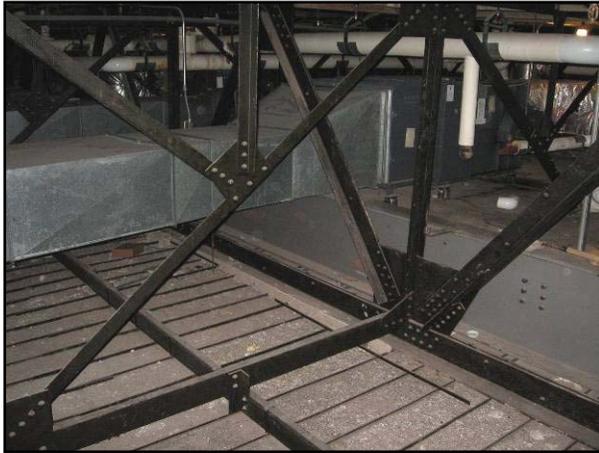
The secondary trusses supporting the roof ribs span approximately 20 feet between the primary building trusses. Primary trusses cross the width of the building and bear on the east and west exterior Brownstone walls (see Photo 51). The top chords of the primary trusses are embedded into the concrete roof deck (see Photo 52). The bottom chords of the primary and secondary trusses support a lattice of steel and timber members that support the plaster and lath ceiling of the third floor office level below. The primary trusses are approximately 7 feet deep. All trusses are composed of standard angle shapes and are assembled using rivets, which was common at the time of their construction.

In general, the main and secondary trusses appear to be in very good condition. Trusses do not appear to be deflecting excessively. Trusses are in plane and no damage to any truss web or chord members was noted. No missing rivets were observed. No areas of steel deterioration were noted, except for some areas of minor rusting near locations where water has leaked through the roof slab. Most of the staining resulting from these leaks seems to have occurred around the roof drains along the east and west edges of the building (see Photo 53). None of the stains appears to be new. The concrete in some of these localized areas is in fair to poor condition.

Photo 51 – Secondary Roof Trusses (left) framing into Primary trusses (right), above Great Hall

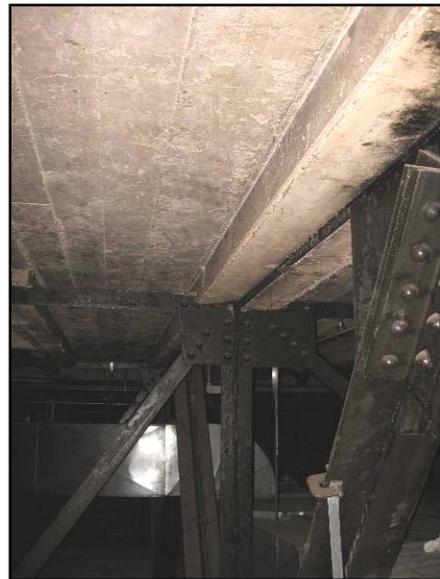
Photo 52 – Primary Roof Trusses at Great Hall (Note top chord of truss encased in concrete)

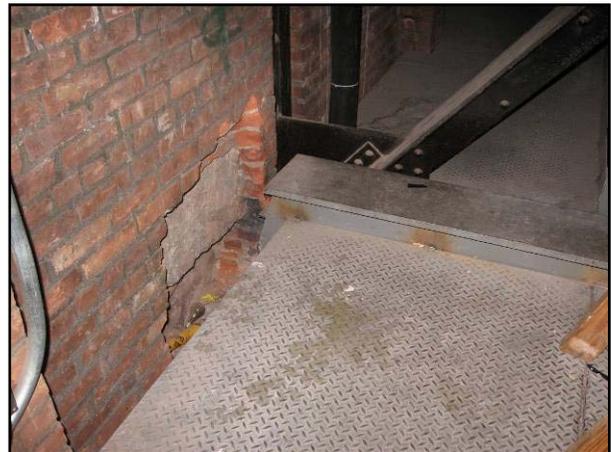
At some point in the past, a supplementary steel deck system was added in the attic space to support new air handling units and large ducts. This system of platforms is supported by steel wide-flange beams spanning the width of the building and bearing on the perimeter Brownstone walls (see Photos 54 & 55). It is our opinion that these 27 inch-deep beams were "inserted" into the attic space through holes created in the exterior Brownstone walls. It appears that individual Brownstone pieces were removed and re-laid after the beams were installed and secured. Beams bear on the Brownstone at pockets created at each side of the building. Steel channels span between the main beams and support a checker-plate steel deck. The mechanical platforms are self-supporting and are not connected to the building trusses. There are three such platforms in the attic and the structures of the platforms appear in excellent condition.

Photo 54 – Supplementary Steel Deck System (Note beam support extending to exterior wall)

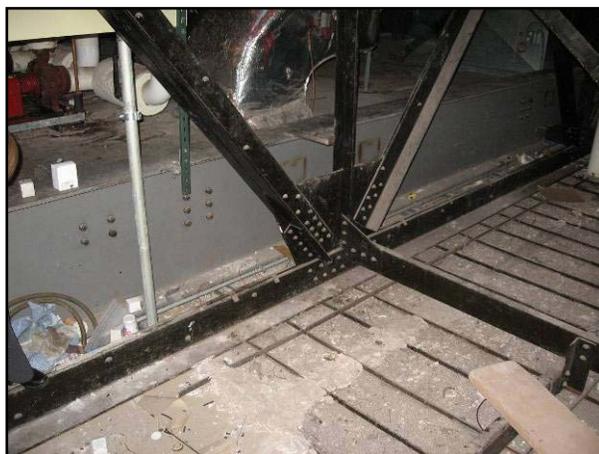
Photo 55 – Supplementary Steel Deck System with Perimeter Beam Support, Adjacent to Primary Truss

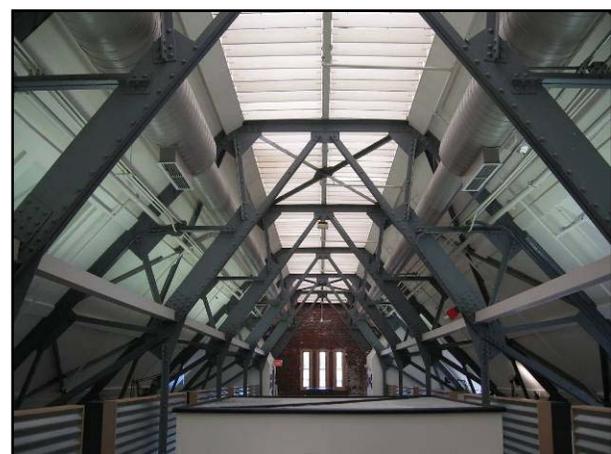
Based on existing building plans, the roof on the north and south office wings is made up of a concrete slab spanning between integral concrete stiffening ribs. These ribs bear on steeply sloped trusses which define the extreme pitch of the roof (see Photo 56). The opposing trusses are sloped toward each other and are connected at the top to form a flat plane. This flat roof area is covered with a translucent skylight in the office space on the north wing of the building and a ballasted EPDM roof in other areas. These trusses are comprised of steel plate and angle members and appear to be in very good condition. Trusses did not appear to deflect and all rivets appeared to be present. The condition of the concrete roof slab and integral ribs could not be observed because of drywall finishes.

Photo 56 – Roof Trusses at 3rd Floor Wing Office Space

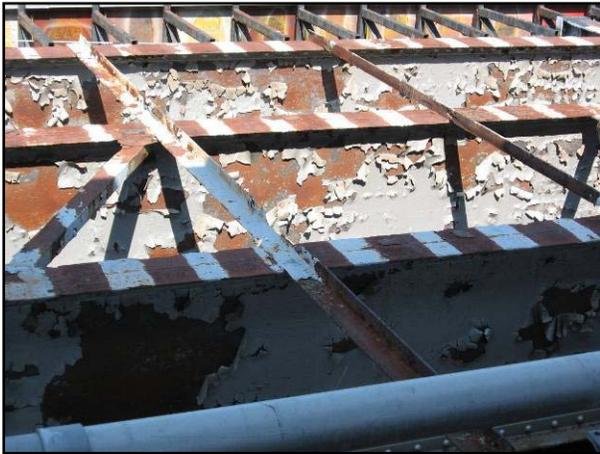
Description: Trestle Structure - The trestle structure is comprised of floor beams spanning north-south between primary girders on main grid lines at 25 feet on center. All floor beams and girders are built-up plate members composed of a steel plate web and angle flange members. A system of steel angles brace the top flanges of the floor beams in some locations. Rivets are used for all connections. (See Photo 57 for a general view of the exposed trestle framing, including top flange bracing elements.)

- The top flange of several beams and girders are significantly rusted (see Photos 57 & 60). The load carrying capacity of these members could be compromised. It is recommended that a more comprehensive inspection and analysis of the trestle structure be performed.

Photo 57 – Exposed Trestle Framing, West of Central Platform

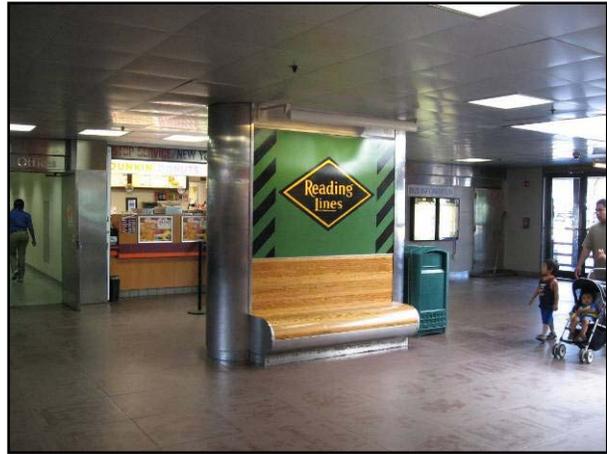
The girders are supported by laced columns at 22 and 24 feet on center. The columns are exposed except at the Transportation Center where they are concealed by a variety of walls and architectural treatments (see Photo 58). The columns generally coincide with roof drain locations in the Ground Transportation Center and can be accessed by service doors in various locations.

Photo 58 – Architectural Finishes Concealing Trestle Columns (“Reading” sign & associated finishes)

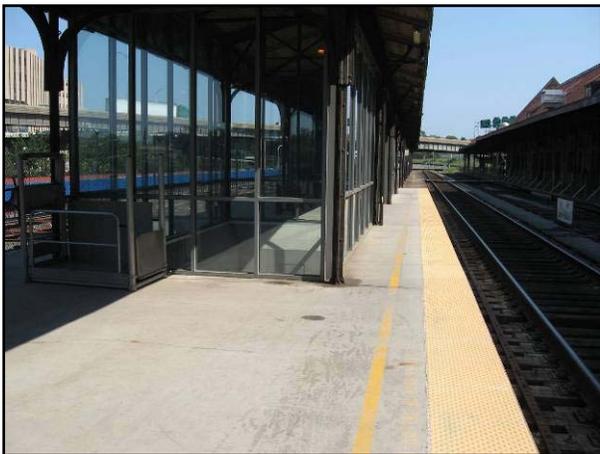
Photo 59 – Concrete Deck at Platform with Amtrak Rail Line to Left

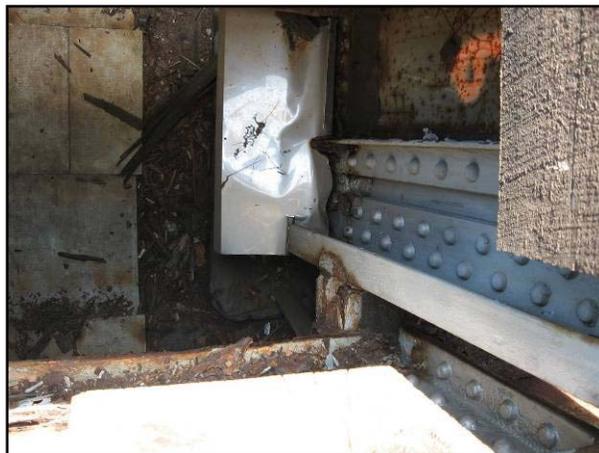
- Significant rusting was observed on the columns and column bases at the pitch pan drain locations in the Ground Transportation Center (see Photos 63 & 64). It appears that there is chronic leaking in and around the pitch pan locations on the roof of the Transportation Center and water continues to drain down the columns. Flashing that has been installed around the columns at the roof appears to be ineffective in directing water away from the column (see Photo 65).
- Observations relating to the safety issues of the platform and egress stairs as documented in the architectural safety and security section.

Photo 65 – View from Above of Flashing around Laced Column, Ground Transportation Center

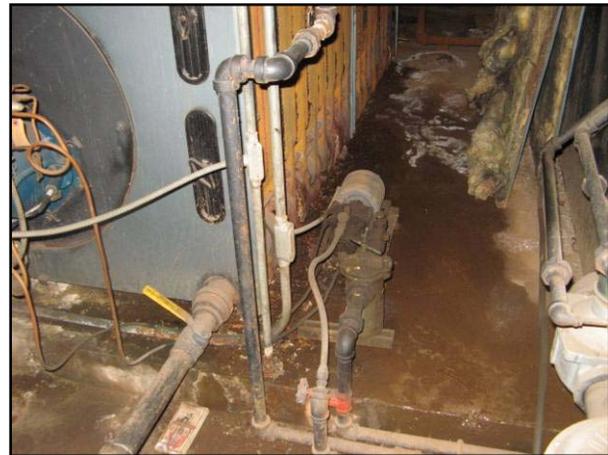
Photo 71 – Boiler #1 – Enclosure Panels Removed Exposing Cast Iron Sections

⁸ It is within the current GHTD grant budget to replace the boilers.

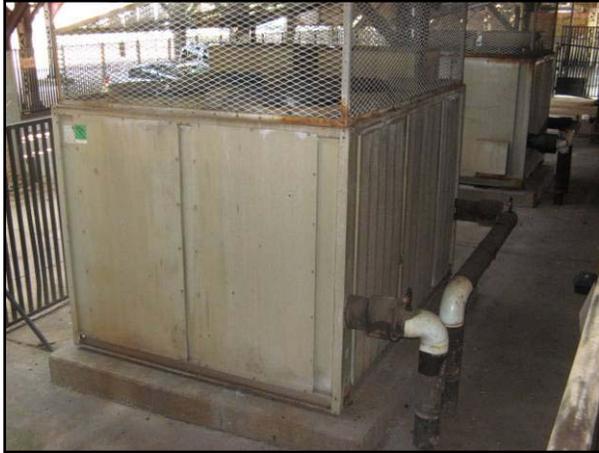
Photo 72 – Air Cooled Water Chillers Located below Rail Platform

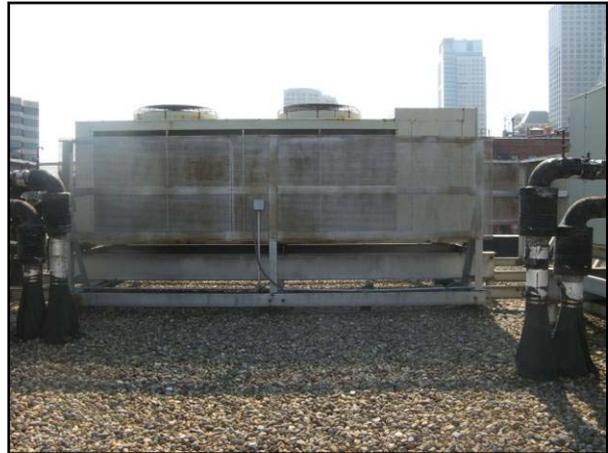
Photo 73 – Air Cooled Water Chiller Located on Roof

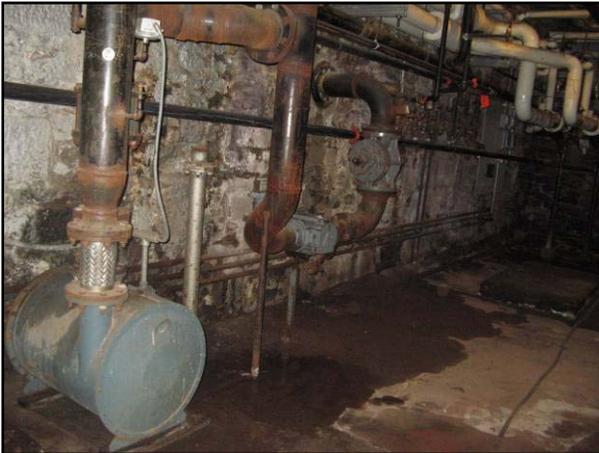
Photo 74 – Natural Gas Service in Basement Mechanical Room

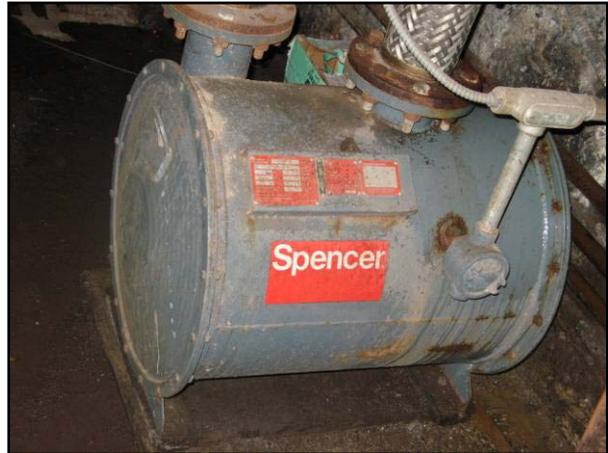
Photo 75 – Spencer Gas Booster Pump in Basement Mechanical Room

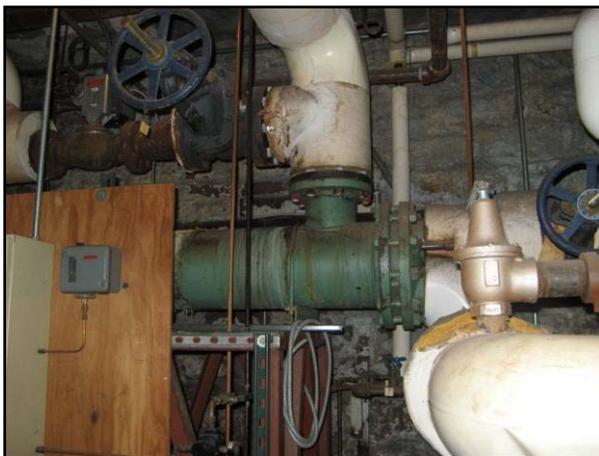
Photo 76 – Steam to Water Shell and Tube Heat Exchanger In Basement Mechanical Room

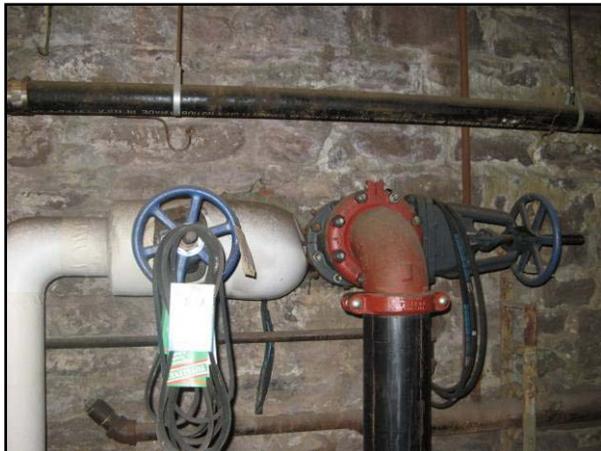
Six inch water service for the fire protection system enters the basement Mechanical Room from the east wall (Union Street) side. A Watts back-flow preventer is installed on the fire service main. A wet pipe system provided with a Viking Model H-1 alarm check valve feeds the sprinkler system. No hydraulic nameplate date identifies the system capacity.

Photo 83 – Domestic Water Service (left) and Fire Service (right) in Basement Mechanical Room

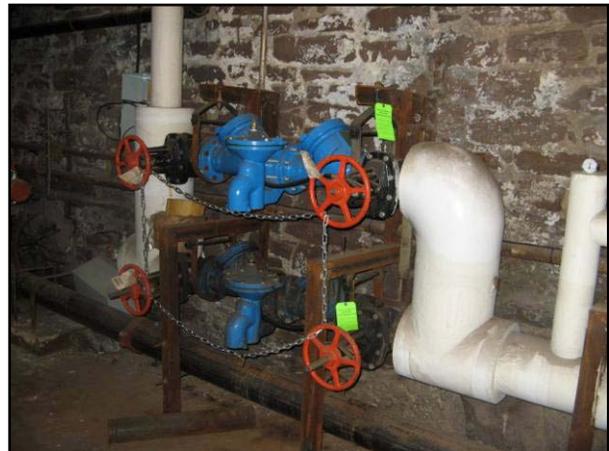
Photo 84 – Domestic Water Service Backflow Preventers in Basement Mechanical Room

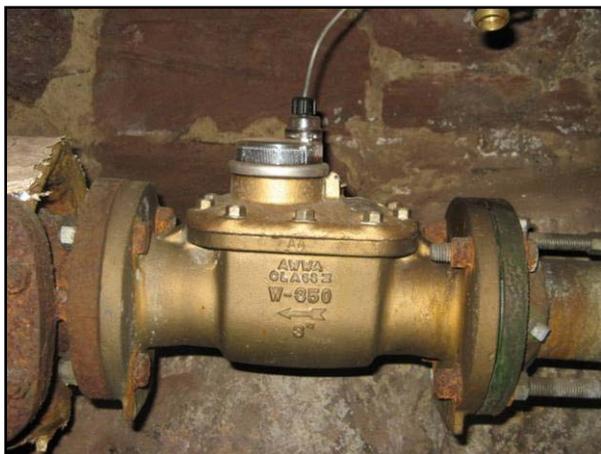
Photo 85 – Water Meter in Basement Mechanical Room

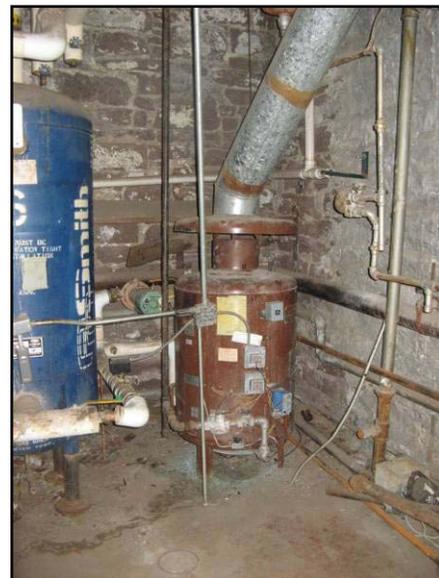
Photo 86 – Domestic Water Heater in Basement Mechanical Room

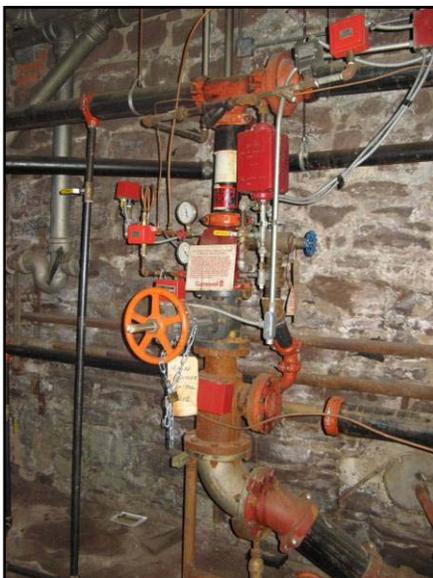
Photo 87 – Sprinkler Riser Assembly in Basement Mechanical Room
