## Existing Conditions Assessment

### 2.1 Transportation System

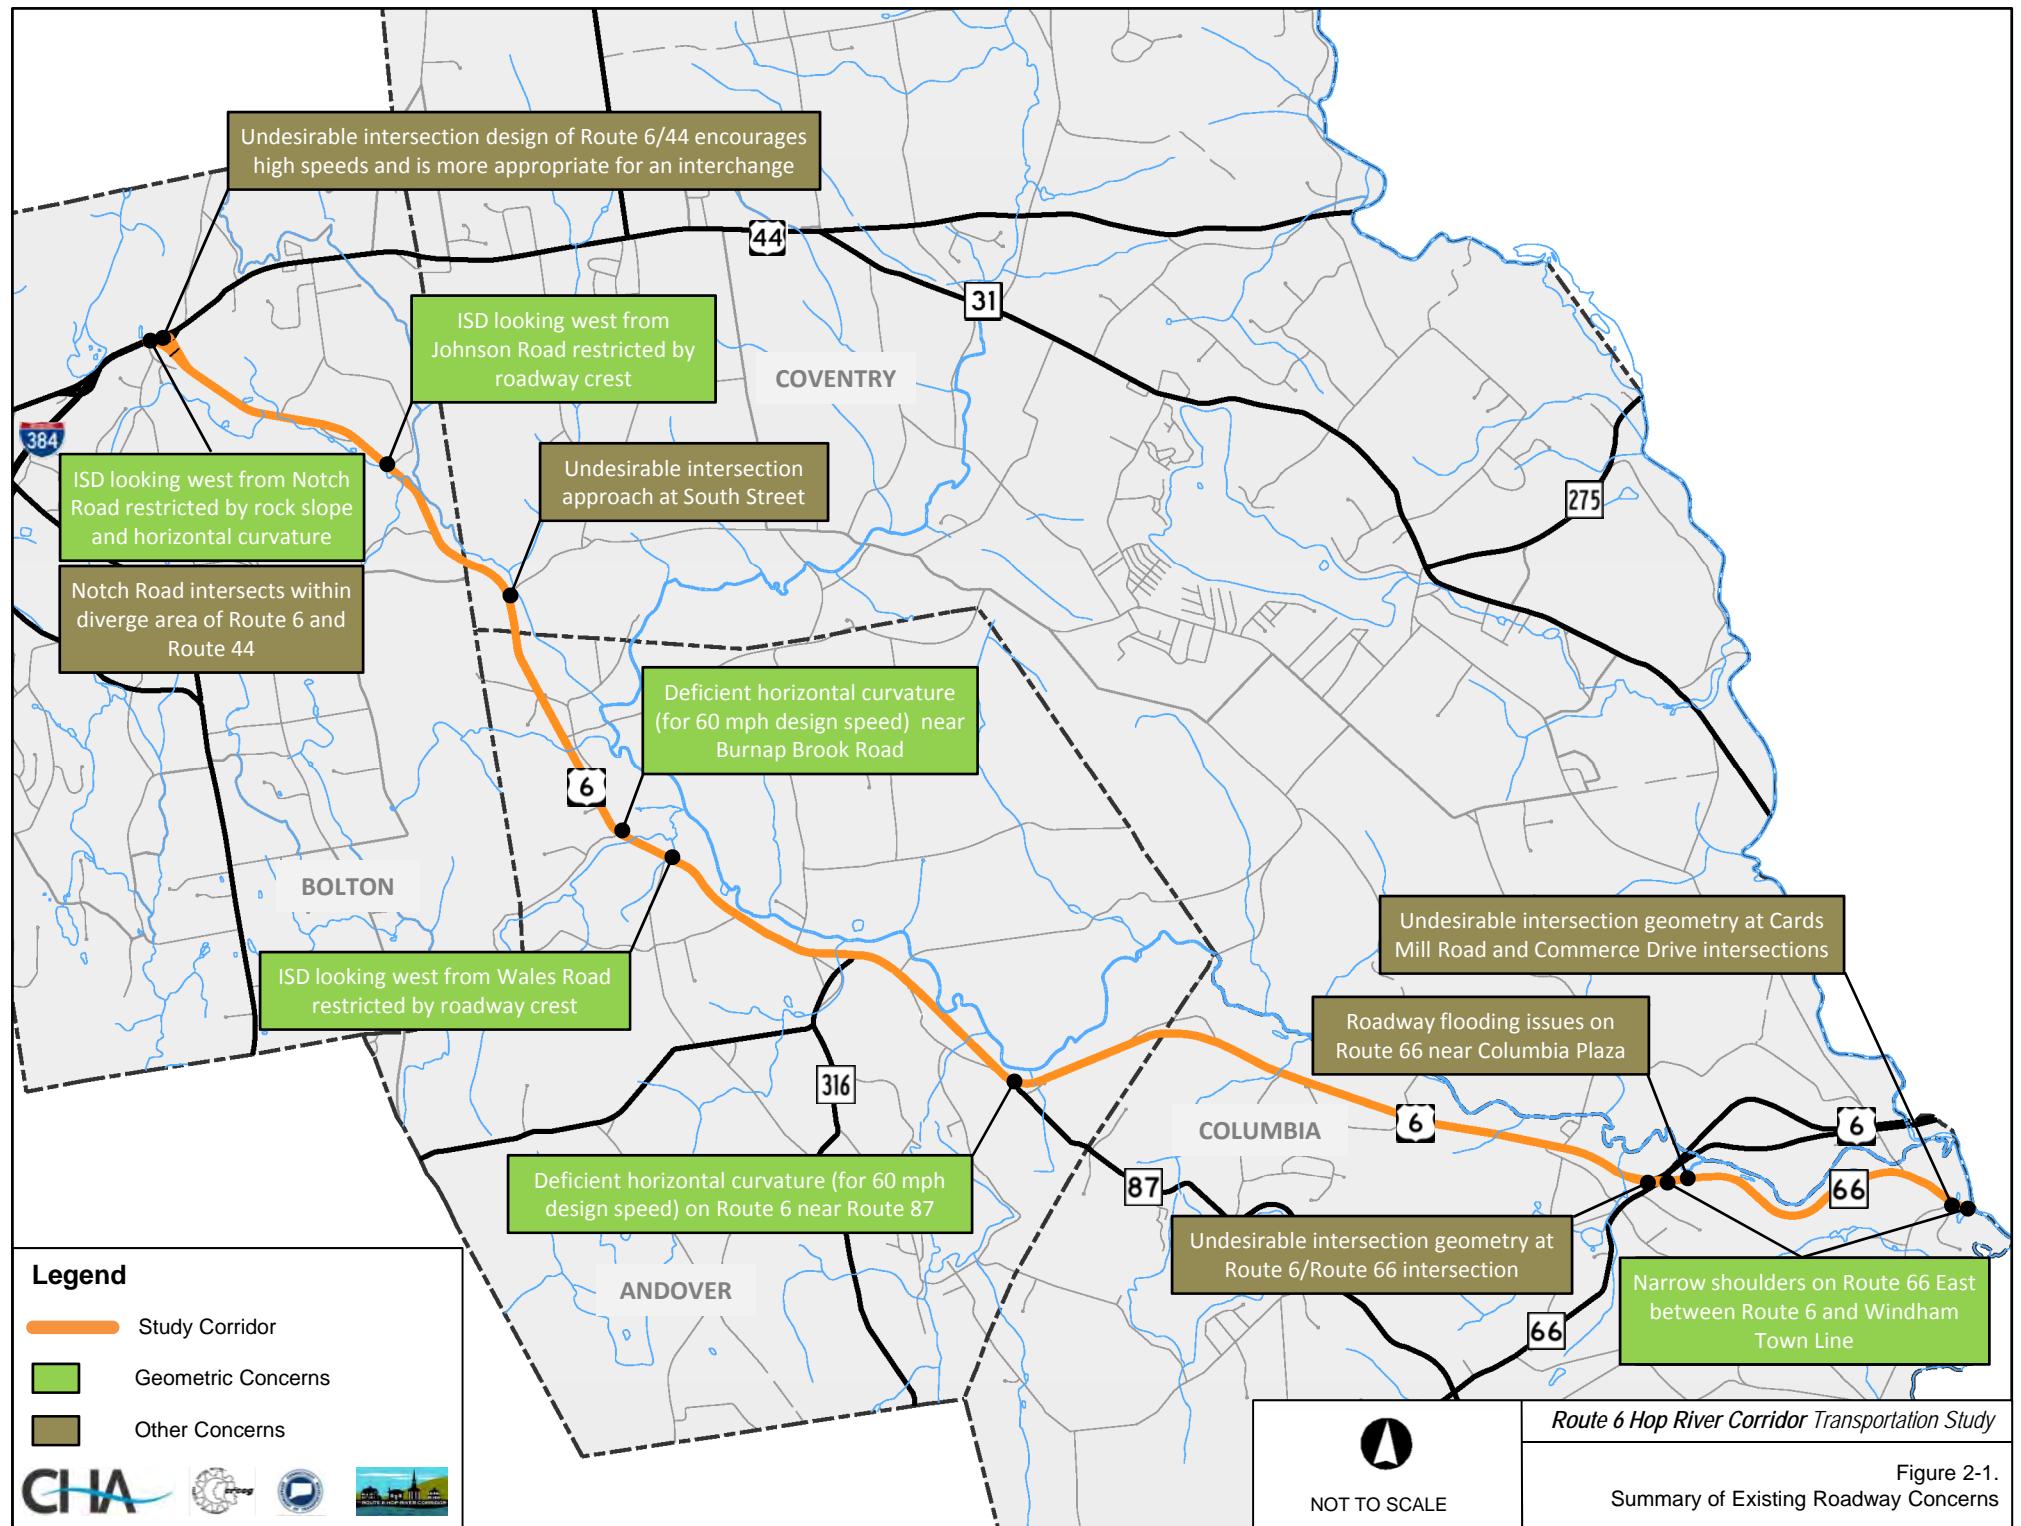
Using a combination of aerial photographs, field observations, and field measurements, the study team assessed the geometric characteristics of Route 6 and Route 66 to determine locations where the existing roadways do not meet CTDOT's current standards. A summary of deficiencies is provided in Table 2-2 and illustrated in Figure 2-1.

In addition to the geometric deficiencies identified above, there are other conditions that are not necessarily substandard, but were identified through the study process as being undesirable. For the purposes of this study, several undesirable roadway conditions in the study corridor have been identified as potential concerns relative travel speeds and safety. These are shown Figure 2-1 and include:

As shown in Table 2-2, the geometric deficiencies in the study corridor include substandard horizontal curvature in two locations on Route 6 and limited intersection sight distances at three unsignalized intersections with Route 6. Although the horizontal curvature is deficient for the assumed design speed of 60 mph in the two noted locations, the curvature exceeds the minimum standard for 55 mph (1065'). Because these locations both have posted speed limits of 50 mph, the deficiencies will not necessarily warrant roadway alignment modifications to increase the existing curve values, but the need for mitigating measures such as improved warning signage in these areas will be investigated.

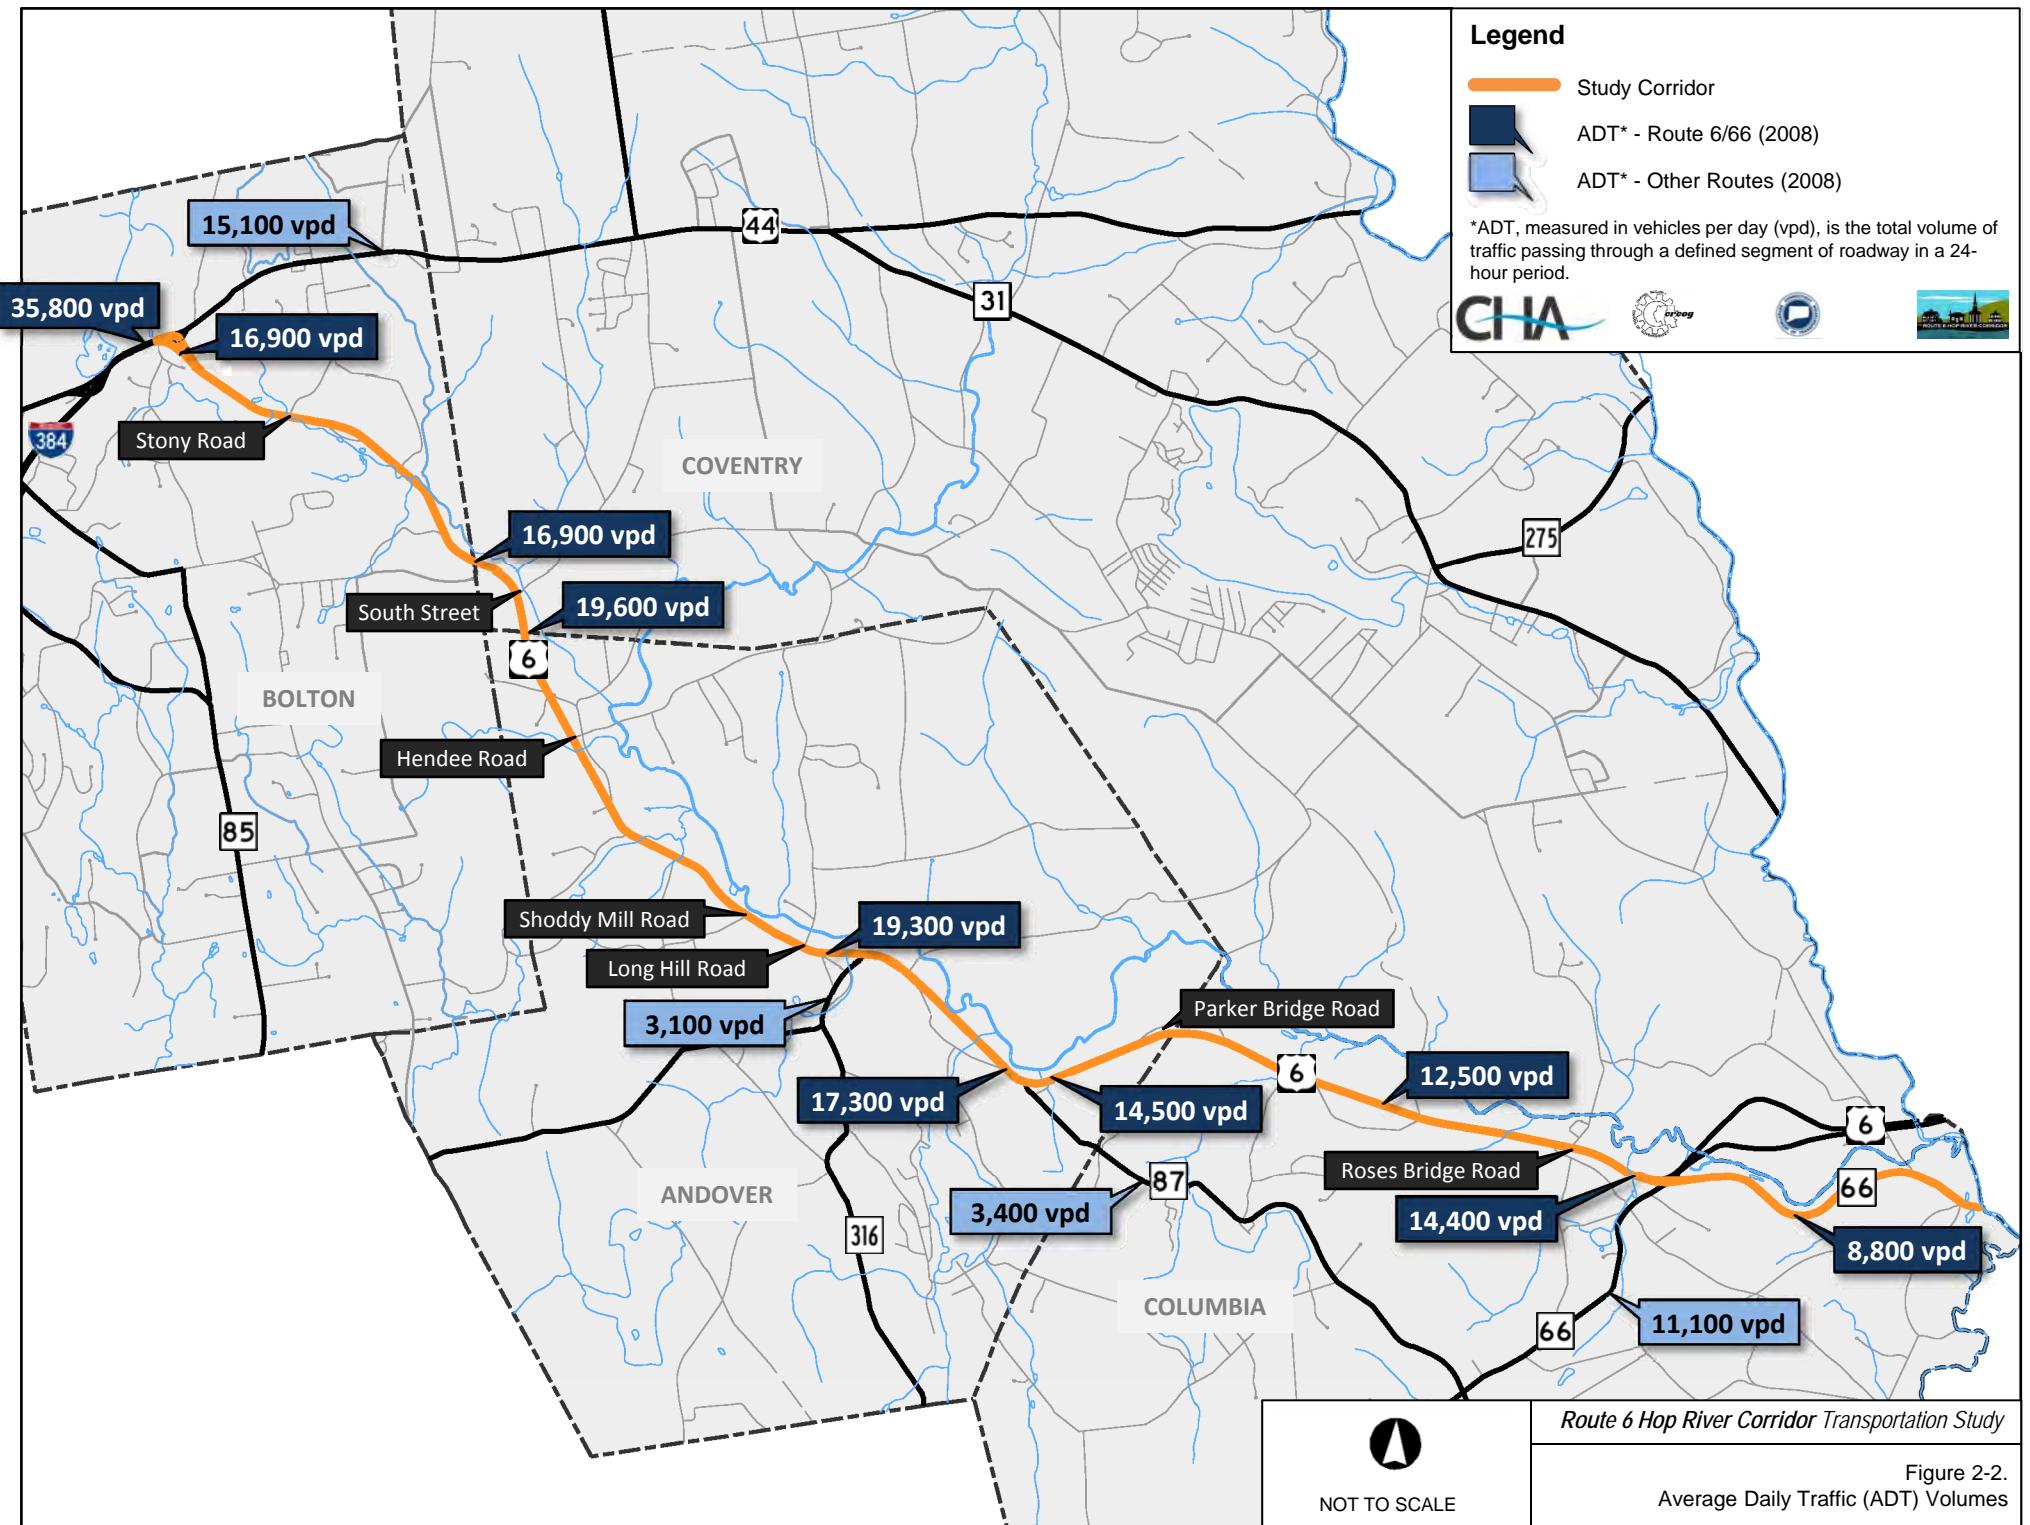
CTDOT maintains a database of average daily traffic (ADT)<sup>1</sup> volumes for all state and some select local roadways that was referenced for this study. The database is updated approximately every three years as new count data is collected. CTDOT most recently collected counts in the study area in 2008. Counts were also collected on four other occasions between 1992 and 2005 in both the Route 6 and Route 66 corridors. The 2008 and historical ADT volumes obtained from CTDOT are summarized in Tables 2-3 and 2-4 for Route 6 and Route 66, respectively. The 2008 ADT volumes for Route 6, Route 66 East, and other roadways proximate to the study corridor are also illustrated in Figure 2-2.

As shown in Table 2-3 and Figure 2-2, traffic volumes on the Route 6/Route 44 overlap are slightly more than double the average daily volume on Route 6 in the study corridor indicating that Route 44 and Route 6 carry approximately the same level of daily traffic. Elsewhere, volumes generally increase traveling east to west through Andover and decrease in Bolton prior to joining with Route 44.

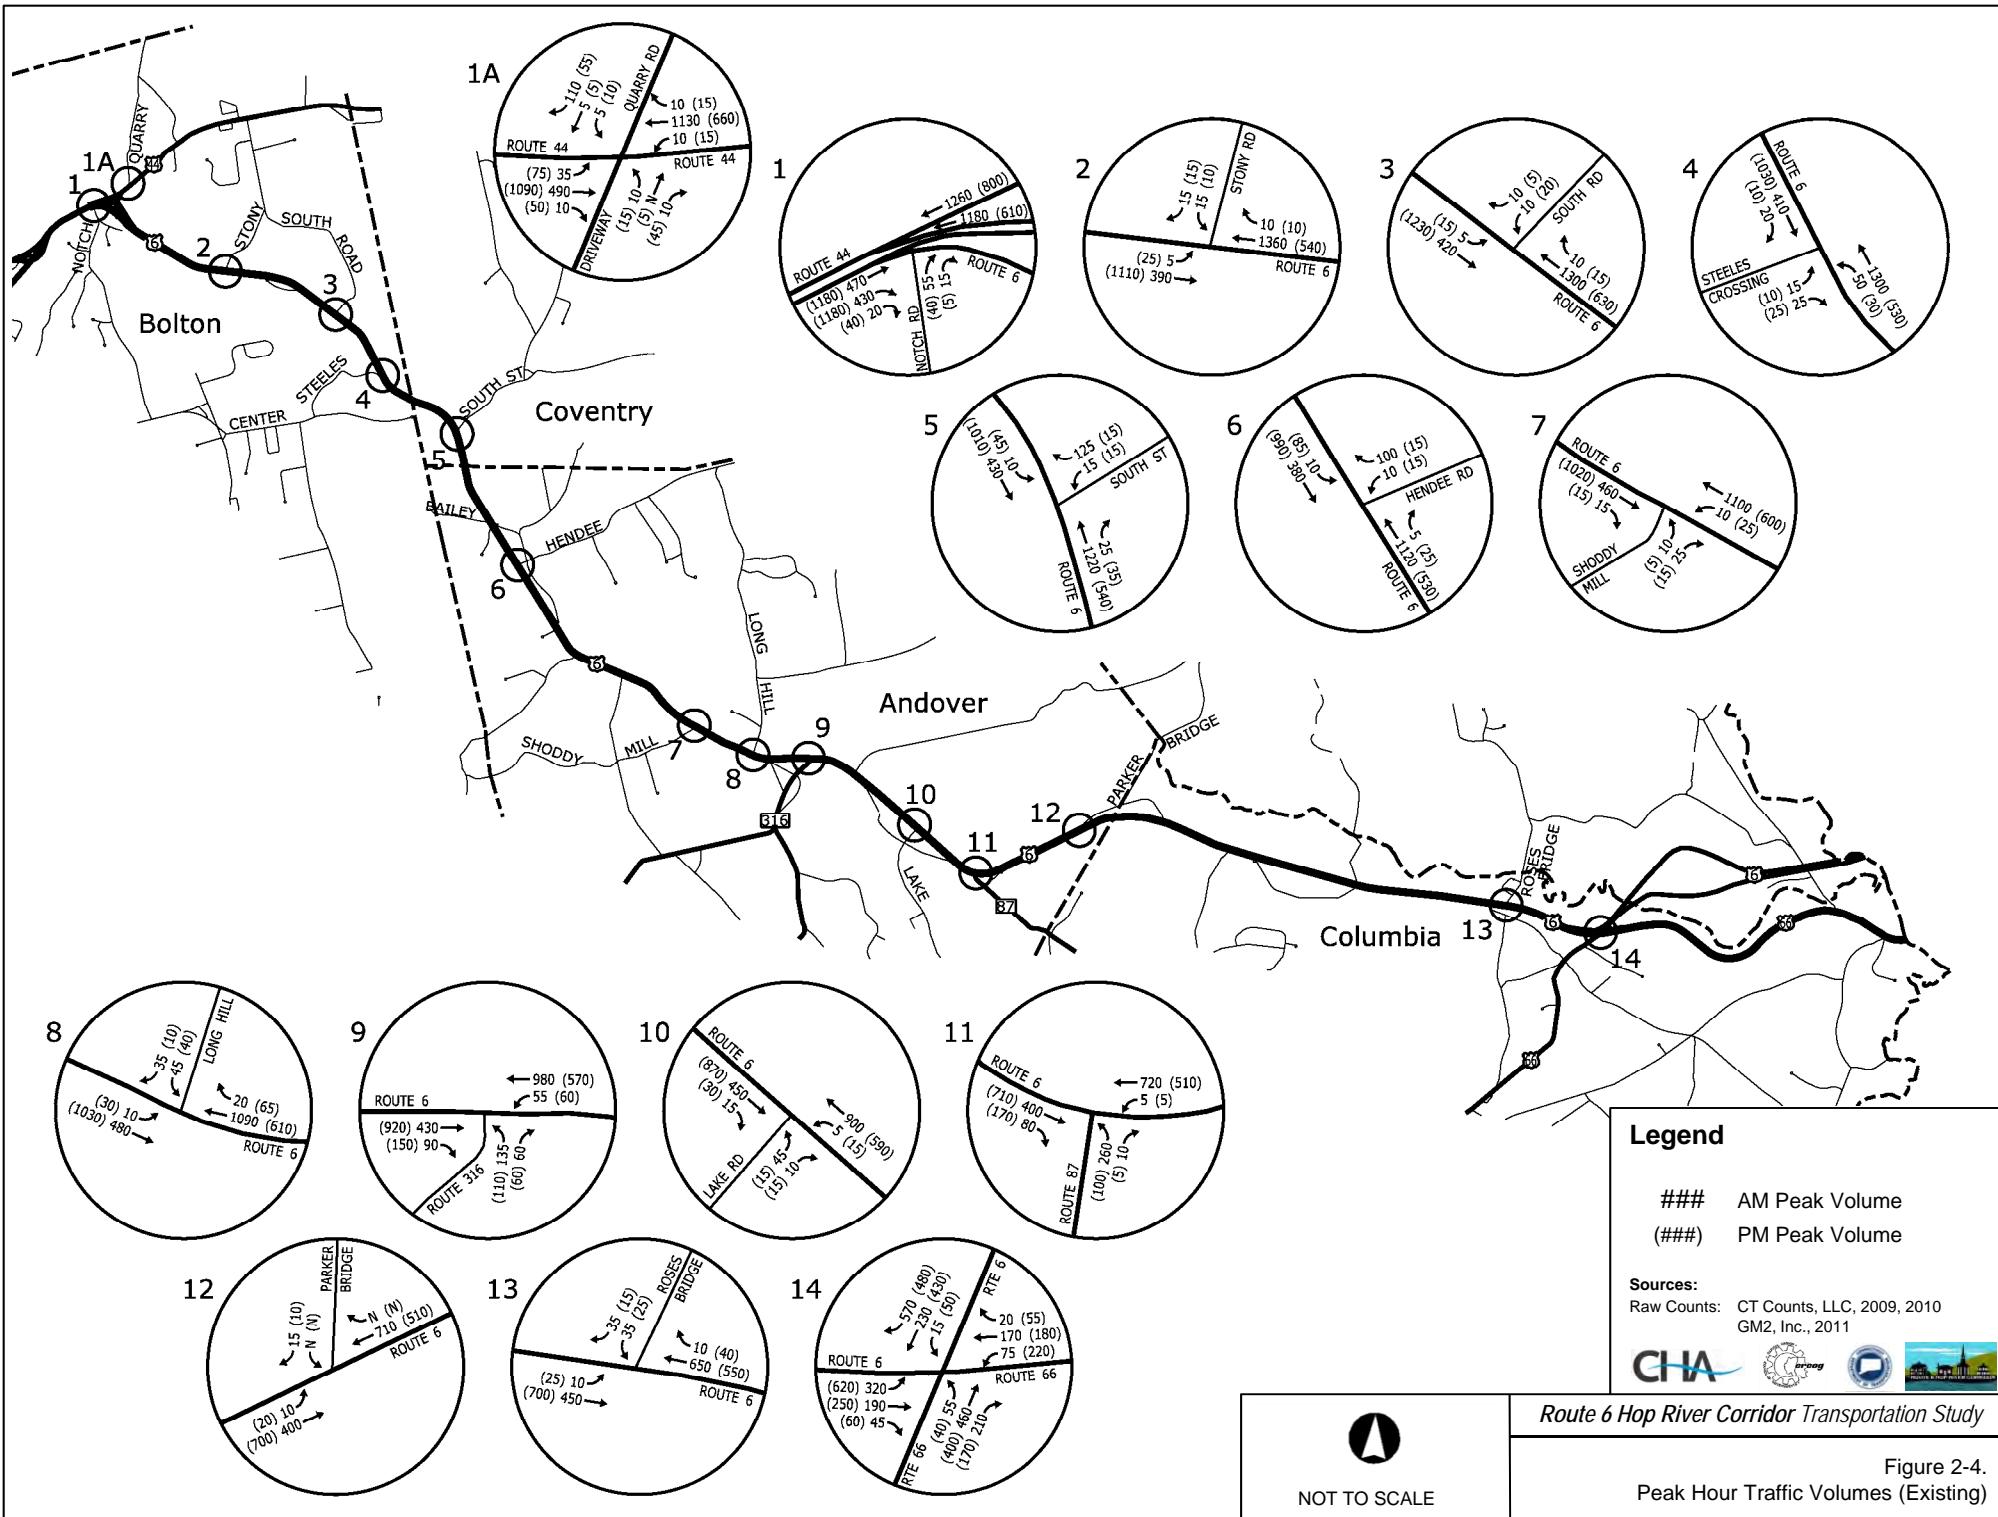
Intersection turning movement counts were obtained for 17 intersections in the study corridor in October 2009 (under REDC's previous study); and in March 2010, April 2010, and September 2011 (under this study). Intersection turning movement counts were performed during the weekday morning (AM) peak period (7 to 9 am) and afternoon (PM) peak period (4 to 6 pm) to capture the influence of the peak daily commuting times. The actual peak hours at these intersections were generally from 7:15 to 8:15 am and from 4:45 to 5:45 pm. A traffic volume diagram representing the AM and PM peak hour traffic volumes is shown in Figure 2-4.

The study team used the volumes shown in Figure 2-4 to characterize peak hour travel trends in the study corridor and to determine existing traffic operations at the 14 study intersections. Peak hour travel trends and existing traffic operations are presented in the following sections.

<sup>4</sup> All percentages represent approximate values as calculated from the traffic volumes shown in Figure 2-4.

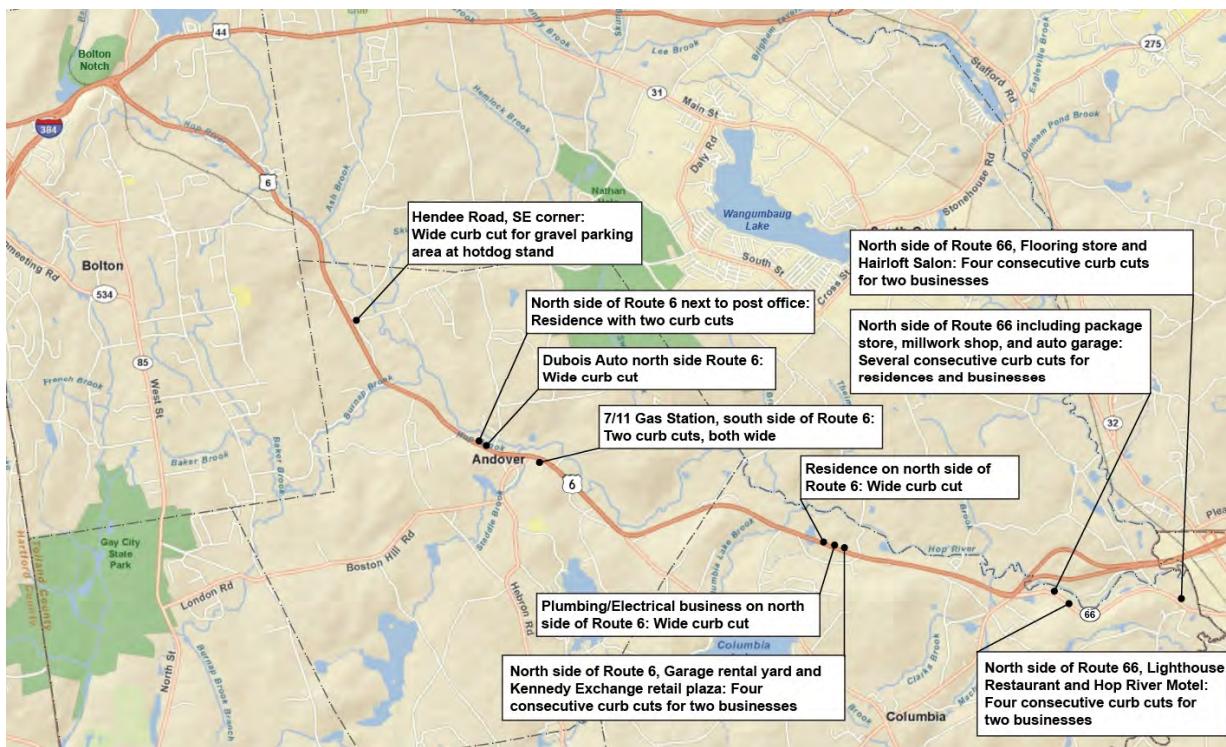
Figure 2-7. Access Management Issues

In general, access management issues in the study corridor include a number of businesses with redundant driveways or businesses with driveways that are wider than necessary. These locations are shown in Figure 2-7.

Opportunities to close redundant driveways, narrow excessively wide driveways, or share driveways between adjacent parcels should be considered in conjunction with the site plan application review and approval process for new development or redevelopment proposals in each town. Strategies to minimize the number of new access points on Route 6 within potential future development nodes will be evaluated as part of this study.

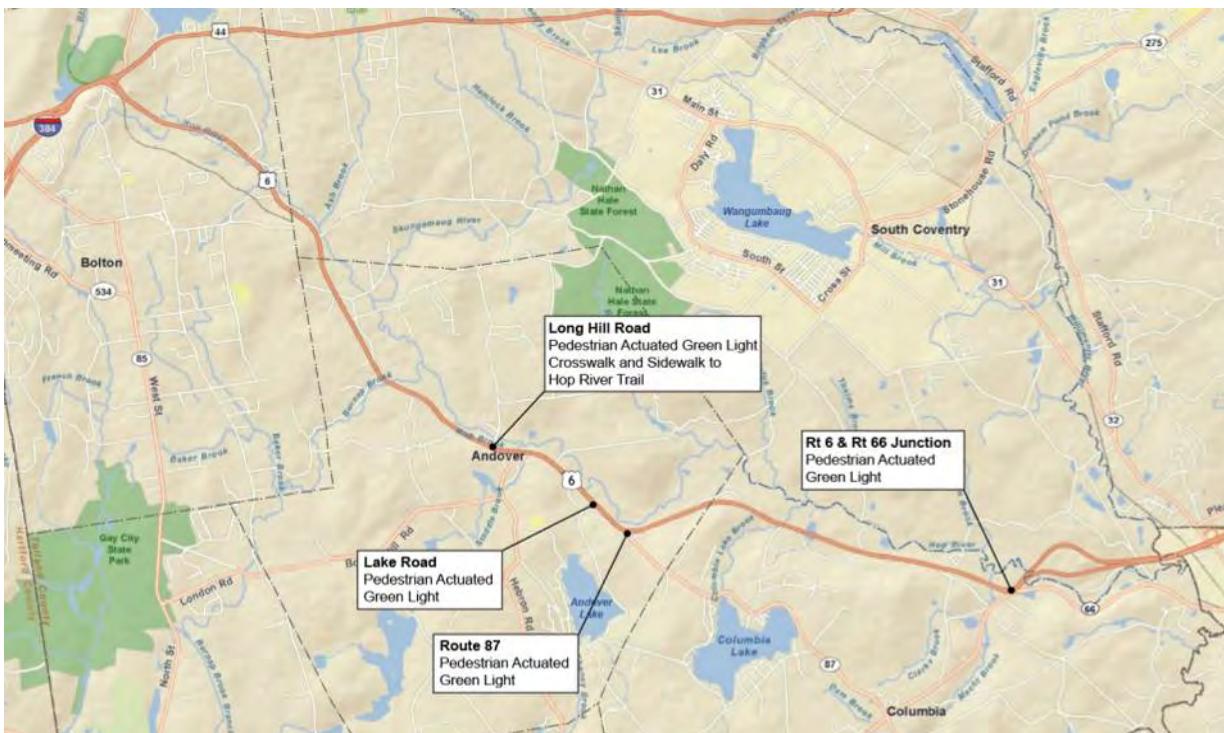
Figure 2-8. Pedestrian Facilities

Being rural in nature, the study corridor generally has no continuous sidewalks. Other pedestrian facilities are limited to four pedestrian actuated intersection crossings and only one crosswalk across Route 6. The locations of these facilities are noted in Figure 2-8, and include:

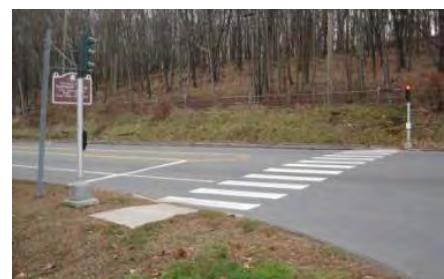
- **At Route 6 and Long Hill Road (Andover),** curb ramps, a marked crosswalk on the east side of the intersection, and a pedestrian actuated green light which is concurrent with the green light for traffic on Long Hill Road. The sidewalk on the south side of the crosswalk extends east towards the Hop River Trail (see The Hop River Trail discussion that follows for trail details). There is no sidewalk on the north side of Route 6 nor a crosswalk on the Long Hill Road approach to the intersection that link the trail and other potential pedestrian destinations like the church, library, Park & Ride lot, post office, and ball fields in this area.

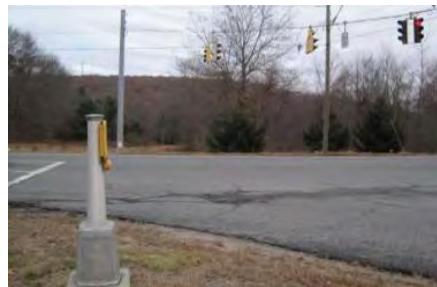
- **At Route 6 and Lake Road (Andover)**, a pedestrian actuated green light used for crossing Route 6. The pedestrian crossing shares the green light with traffic from Lake Road. There are no sidewalks, curb ramps, or crosswalk markings at this location. The only notable destination near this intersection is a convenience store a few hundred feet west of the intersection.

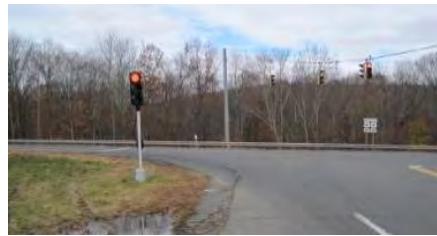
- **At Route 6 and Route 87 (Andover)**, a pedestrian actuated green light used for crossing Route 6. The pedestrian crossing shares the green light with traffic from Route 87. There are no sidewalks, curb ramps, or crosswalk marking at this location. Additionally, there are no retail or business facilities in the proximity of this intersection.

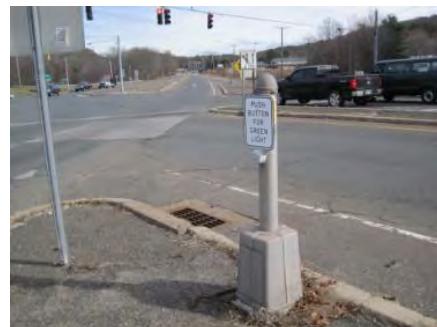
- **At Route 6 and Route 66 (Columbia)**, a pedestrian actuated green light used for crossing Route 6. There is no provision for crossing Route 66. The pedestrian crossing shares the green light with traffic from Route 66. There are no sidewalks, curb ramps, or crosswalk markings at this location. Pedestrian push buttons are located in an island on the southwest corner of the intersection and on an island on the northwest corner. They are isolated and difficult to access. The button on the southwest corner does not function.

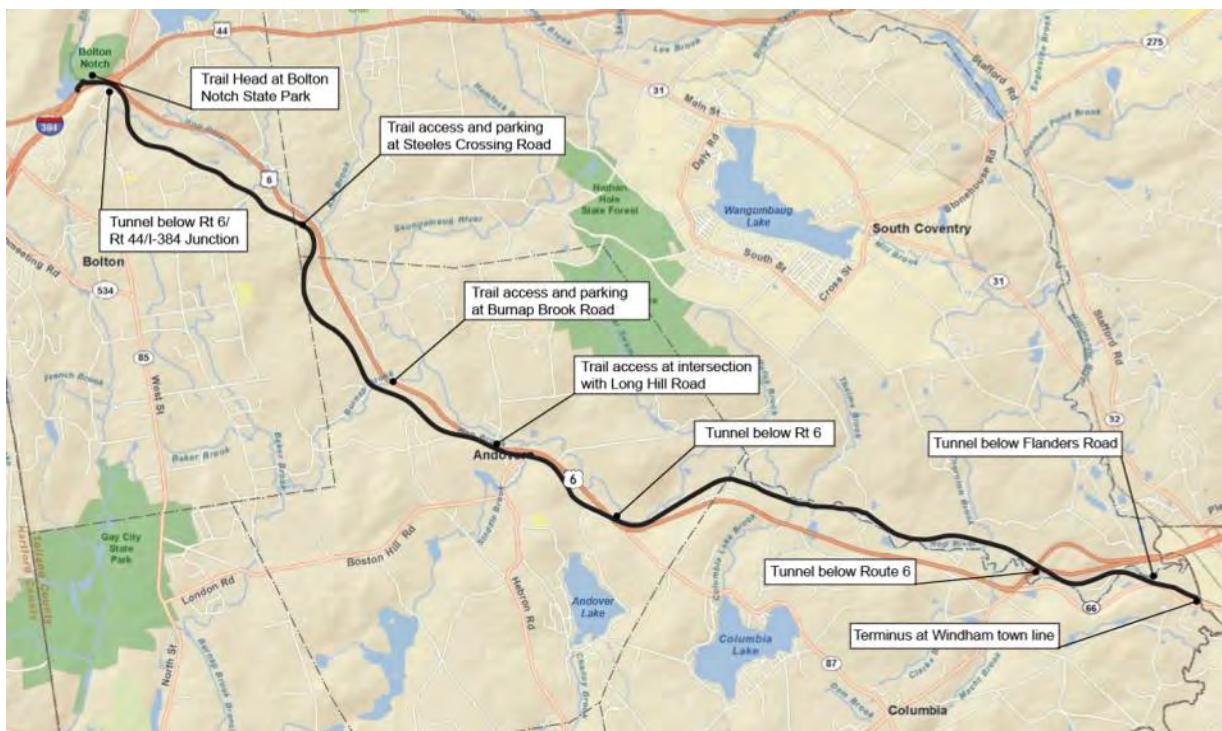
Figure 2-9. Hop River Trail

The placement of the trail varies relative to the road and Hop River. As shown in Figure 2-9, the Hop River Trail is accessible from Bolton Notch State Park via a vehicle-only access drive and trailhead. Just east of the trailhead, the trail passes through a tunnel under Route 6 and continues to be lower in elevation than Route 6 until the grade of Route 6 drops near the Bolton Ice Palace, where the trail becomes higher than adjacent uses. The trail continues through a wooded area to Steeles Crossing Road. There is an informal parking area off Steeles Crossing Road (approximately  $\frac{1}{4}$  mile west of Route 6). There is no signage on Route 6 indicating trail access on Steeles Crossing Road or any of the road crossings to the east. This lack of signage for the trail was noted the length of the corridor.

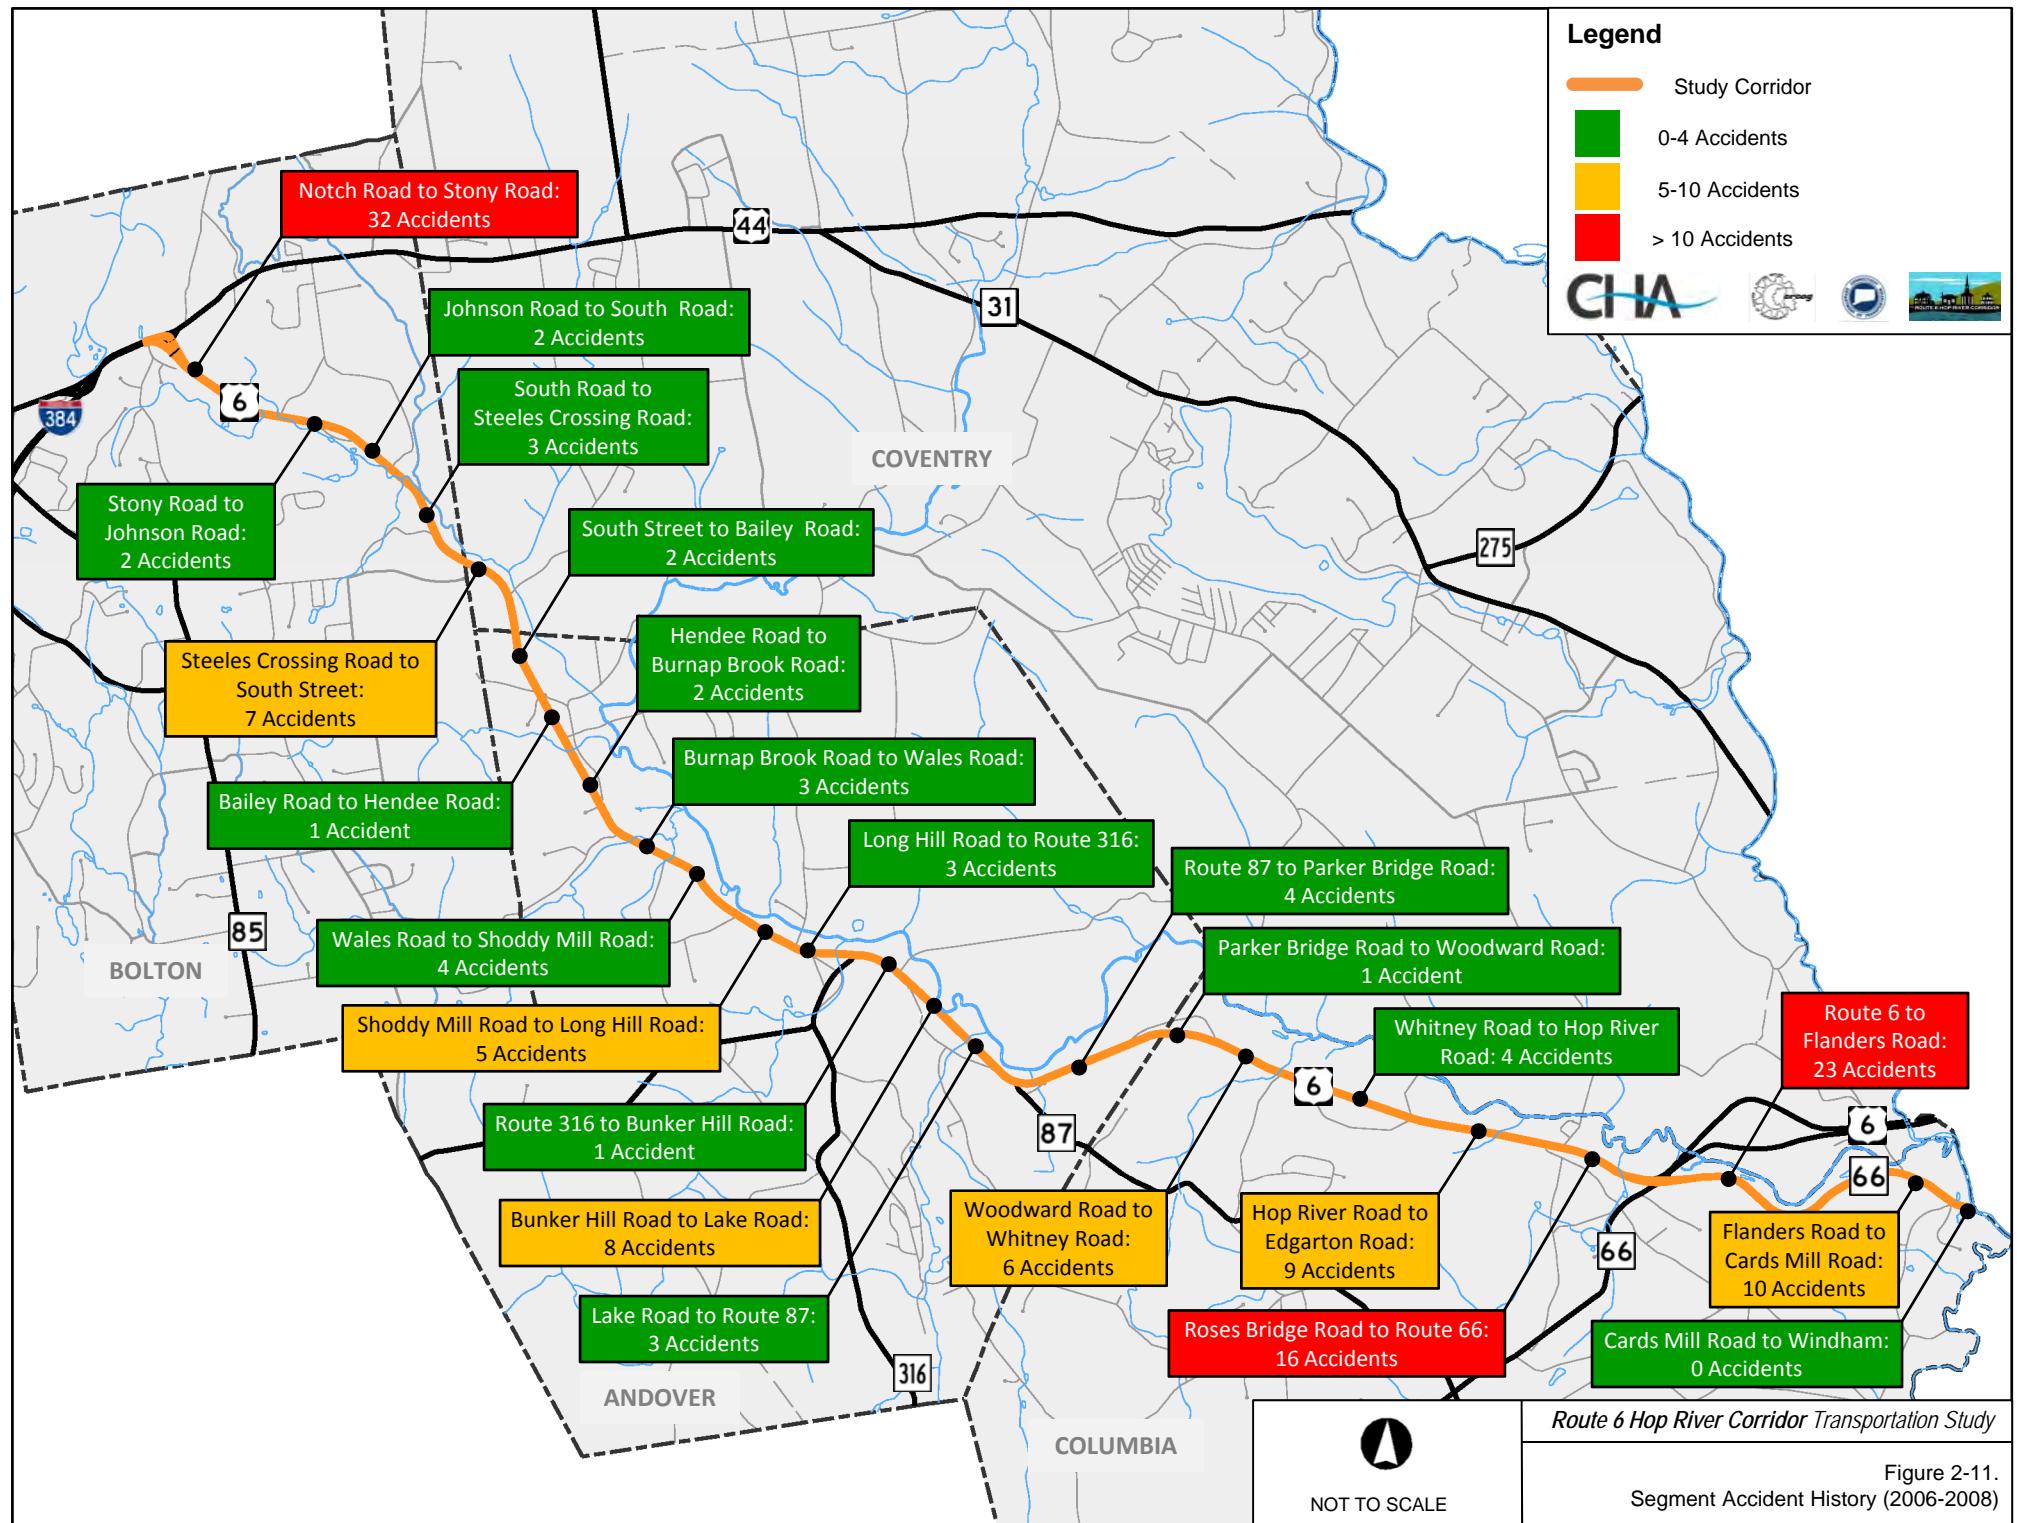
Figure 2-11 and Table 2-11 detail the accident history along each roadway segment (between intersections) in the study corridor.
